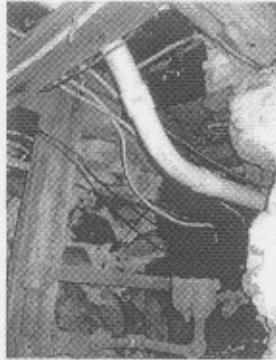
Photo 6 - Rubble Wall Openings

room from the remainder of the building. Compromises in the foundation wall (Photo 6) should be reinstated (although not the most critical need). In the overall integrity of the building, this should be completed and infilled with the structural capacity restored to the facility. Photos 5, 6 and 7 show some of the typical foundation walls within this building.

Rebuild and refill openings in masonry and stone walls that have been compromised over the history of the building.
