**5.0 1957 Single Storey Addition**

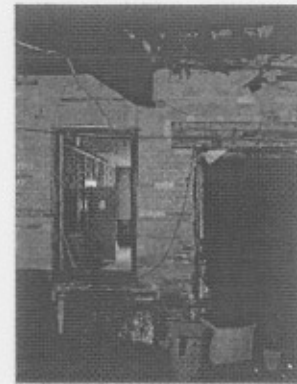
Photo 36 – Beam (1957) Bearing on Masonry (1890)
