### 6.0 Building Exterior – General

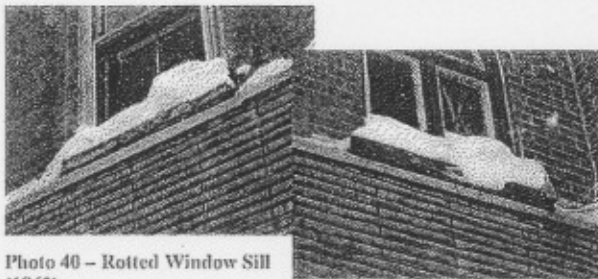
- Rotted lintels and sills – 1863 Building (Photo 40 and 41)
- Loose bricks on chimney (Photo 42)
- Loose soffit and fascia framing on 1890 addition (Photo 43)

Photo 40 – Rotted Window Sill  
(1863)

Photo 41 – Rotted Window Sill  
(1957)

- Immediate removal and/or stabilization of the 1873 sloped two storey portion located west of the original hotel.
- Securing of all loose materials including window sills, loose lintels and loose masonry around the building perimeter. These should be suitably covered and/or removed to prevent falling material.

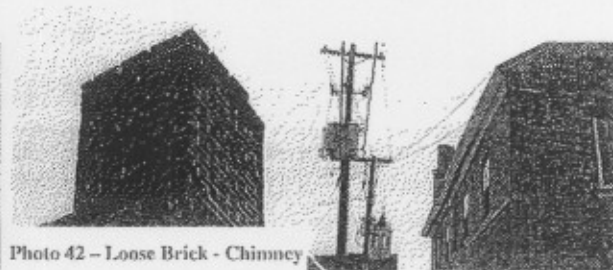
Photo 42 – Loose Brick - Chimney

Photo 43 – Loose Soffit & Fascia  
(1890)
