**Burgoyne Water Works
13-028**

**2019 Operation and Maintenance
Annual Report
January 2020**

**Municipality of Arran-Elderslie Draft Final Report:
Reduction of iron and hydrogen sulfide from a well system using
oxidation and filtration**

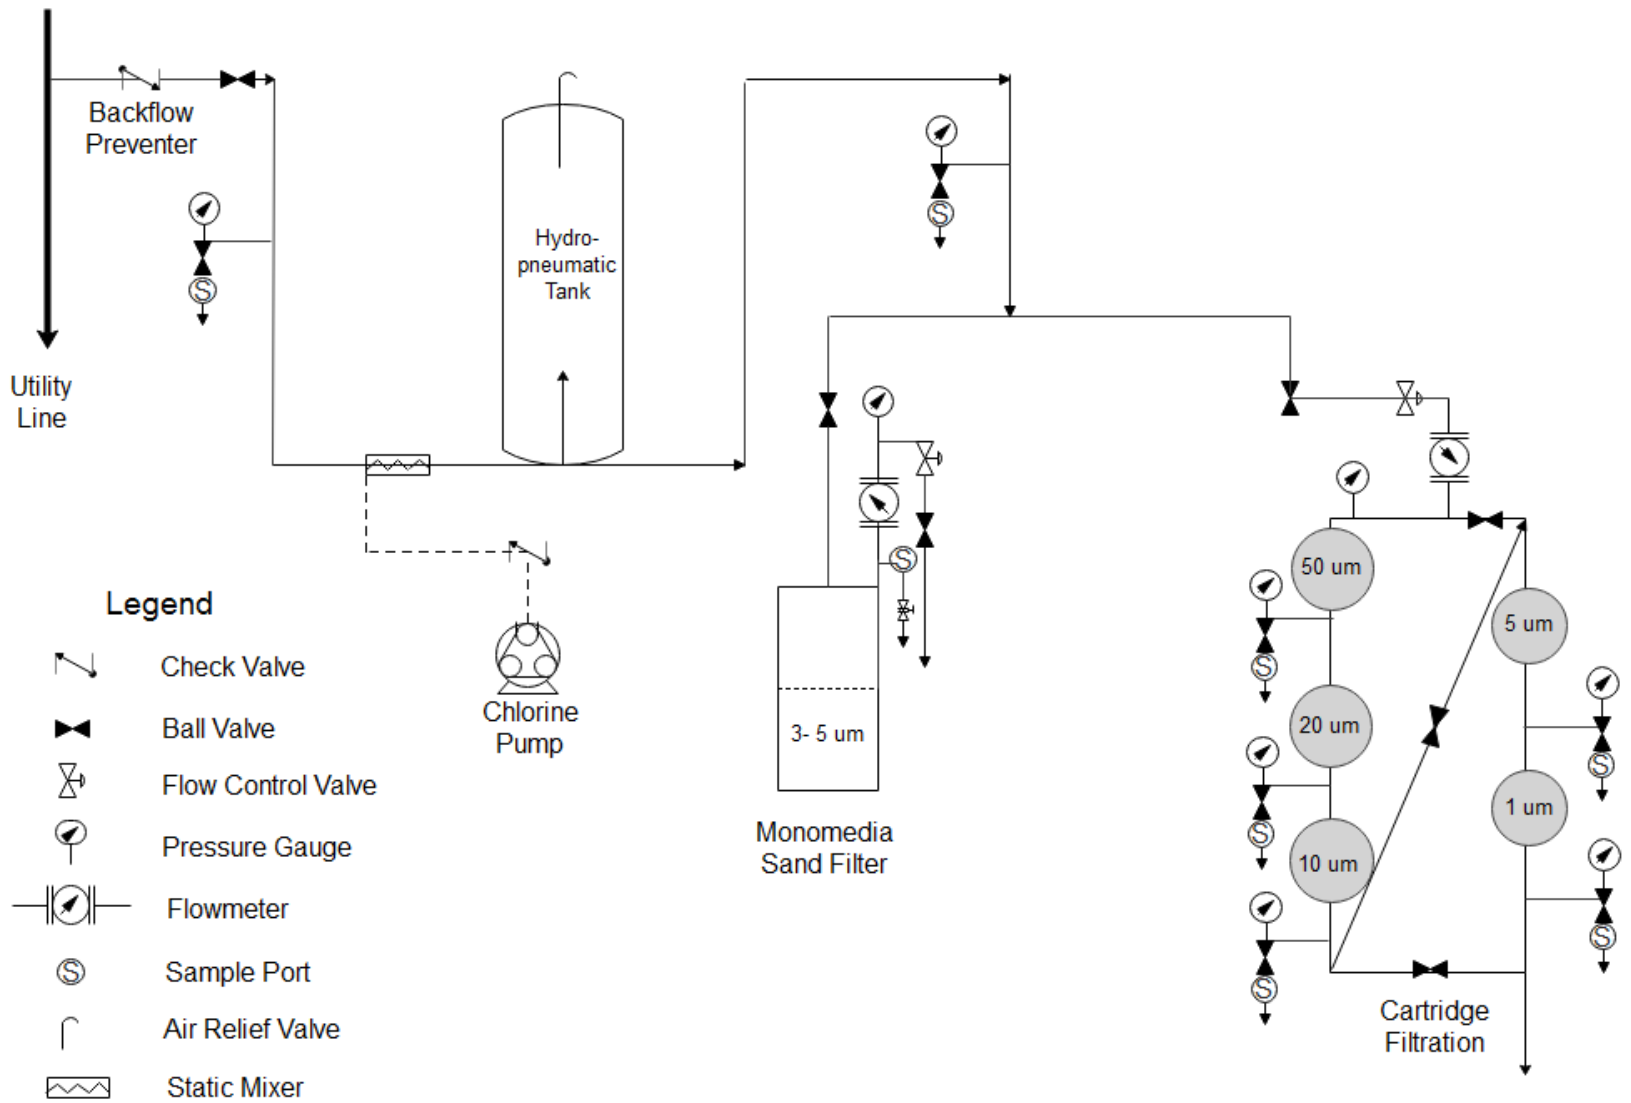
Figure 2. Pilot: Phase 2 Process Flow

Phase 2 omitted aeration from the process and chlorination was added upstream of the hydro-pneumatic tank to increase the chlorine contact time (Figure 2). This was done to determine if the sulfide odour could be reduced and if the size of the iron particles increased with time under the same filtration conditions.

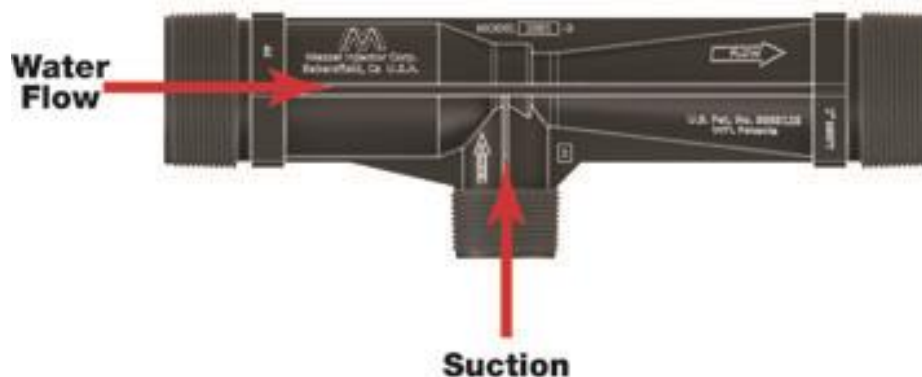
Figure 4. Pilot: Phase 1 Passive (Venturi) Aeration

Passive aeration is a term used for an air injection system that does not require energy, such as a blower or compressor. Instead, water flows in line where the diameter of the pipe narrows abruptly, increasing the velocity, known as a venturi (Figure 4). The increase in velocity creates a vacuum adjacent to a check valve that allows air to be drawn into the pipe but does not let air or water out. The amount of air being drawn into the pipe varies and is controlled by the water flow, pressure, the pipe diameter, and a bypass valve. The system only injects air when water is flowing so there is no need for automation and controls. The system passively injects air because there is no additional energy to the amount of air being applied. Flow meters are available to quantify the air being drawn into the system and specifications are available for sizing units during design. A bypass valve can be used to control the water flow through or around the venturi, thereby allowing the adjustment of air flow through the suction.

The operation and maintenance of this technology is simple, inexpensive, and can be effective; however, the flexibility of the aeration dose is limited. Since aeration is a weak oxidant, conditions such as temperature, contact time, and pH are important for the successful use of aeration as an oxidant. For small applications where chlorine will also be applied as an oxidant, passive aeration is an option. Passive aeration occurs in a closed and pressurized application followed by a hydro-pneumatic tank that controls the amount of air in the system using a float and air relief valve.

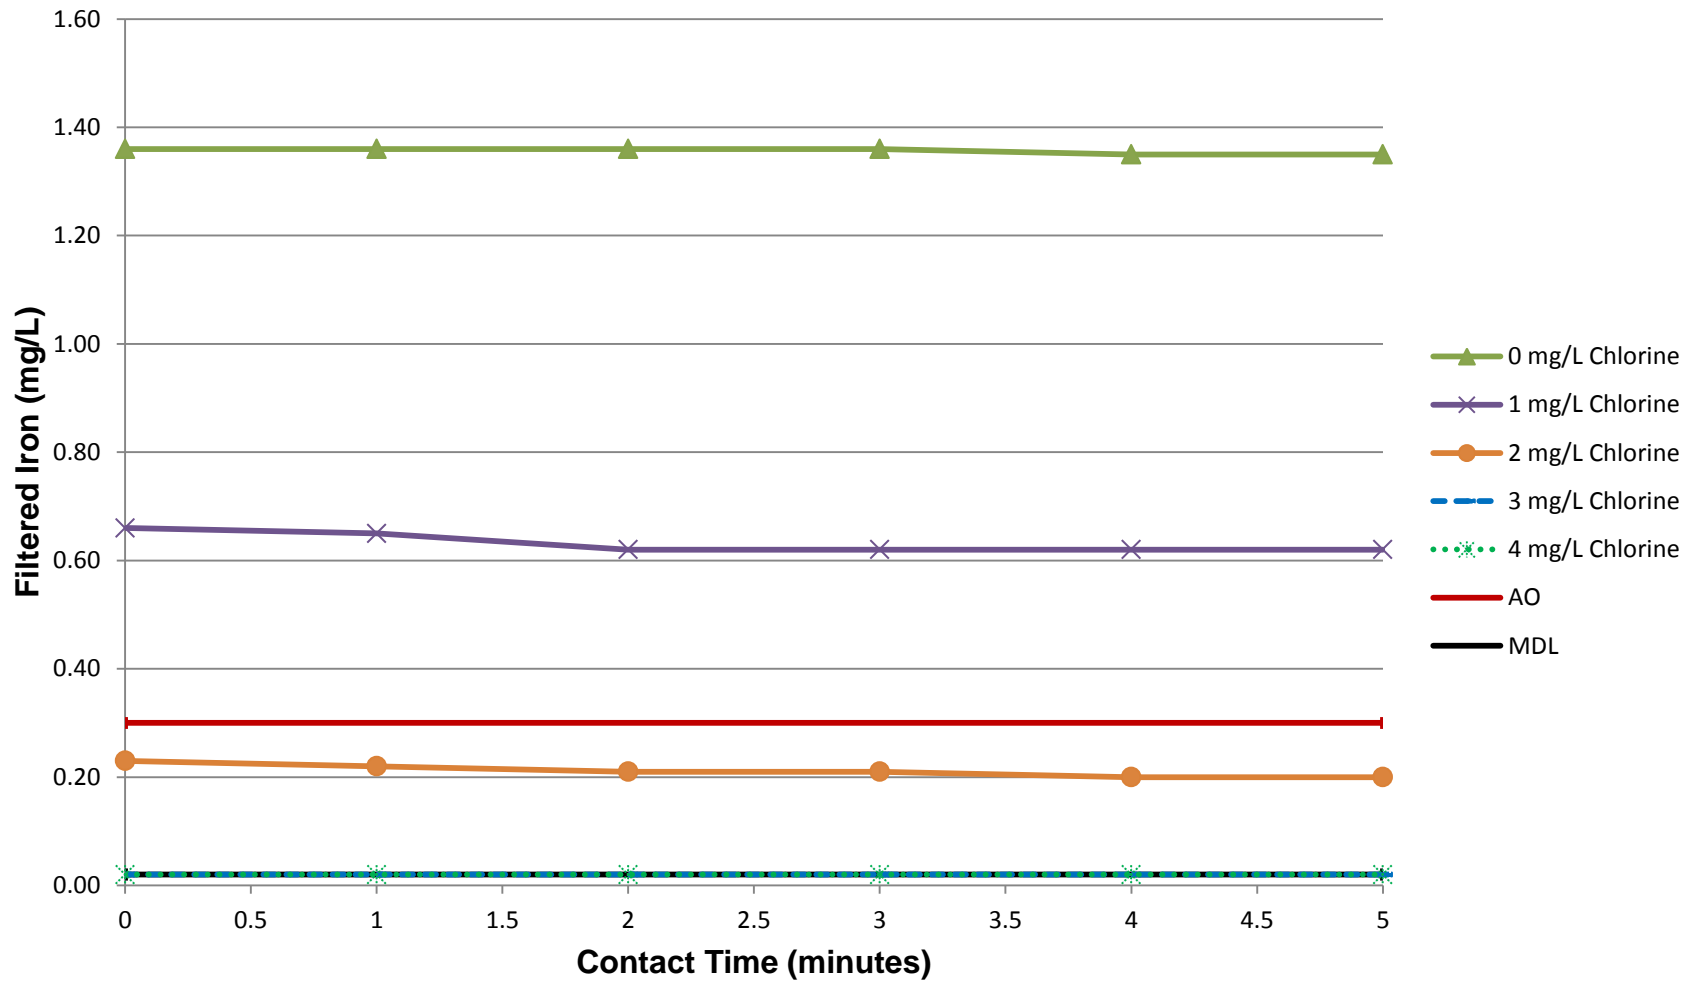
Figure 5. Bench: Objective 2a

Iron was oxidized and filtered out to below the aesthetic objective with a dose of 2 mg/L of chlorine, and reached the method's minimum detection limit with a dose of 3 mg/L (Table 3). The reaction appeared to be instantaneous and similar results were obtained over the 5 minutes of contact time for each corresponding dose as the slope of each plotted line is fairly horizontal (Figure 5). The pH remained within the operational guideline for all chlorine dose treatments.

Filtered Iron Concentrations (mg/L): Chlorine Dose and Contact Time Matrix

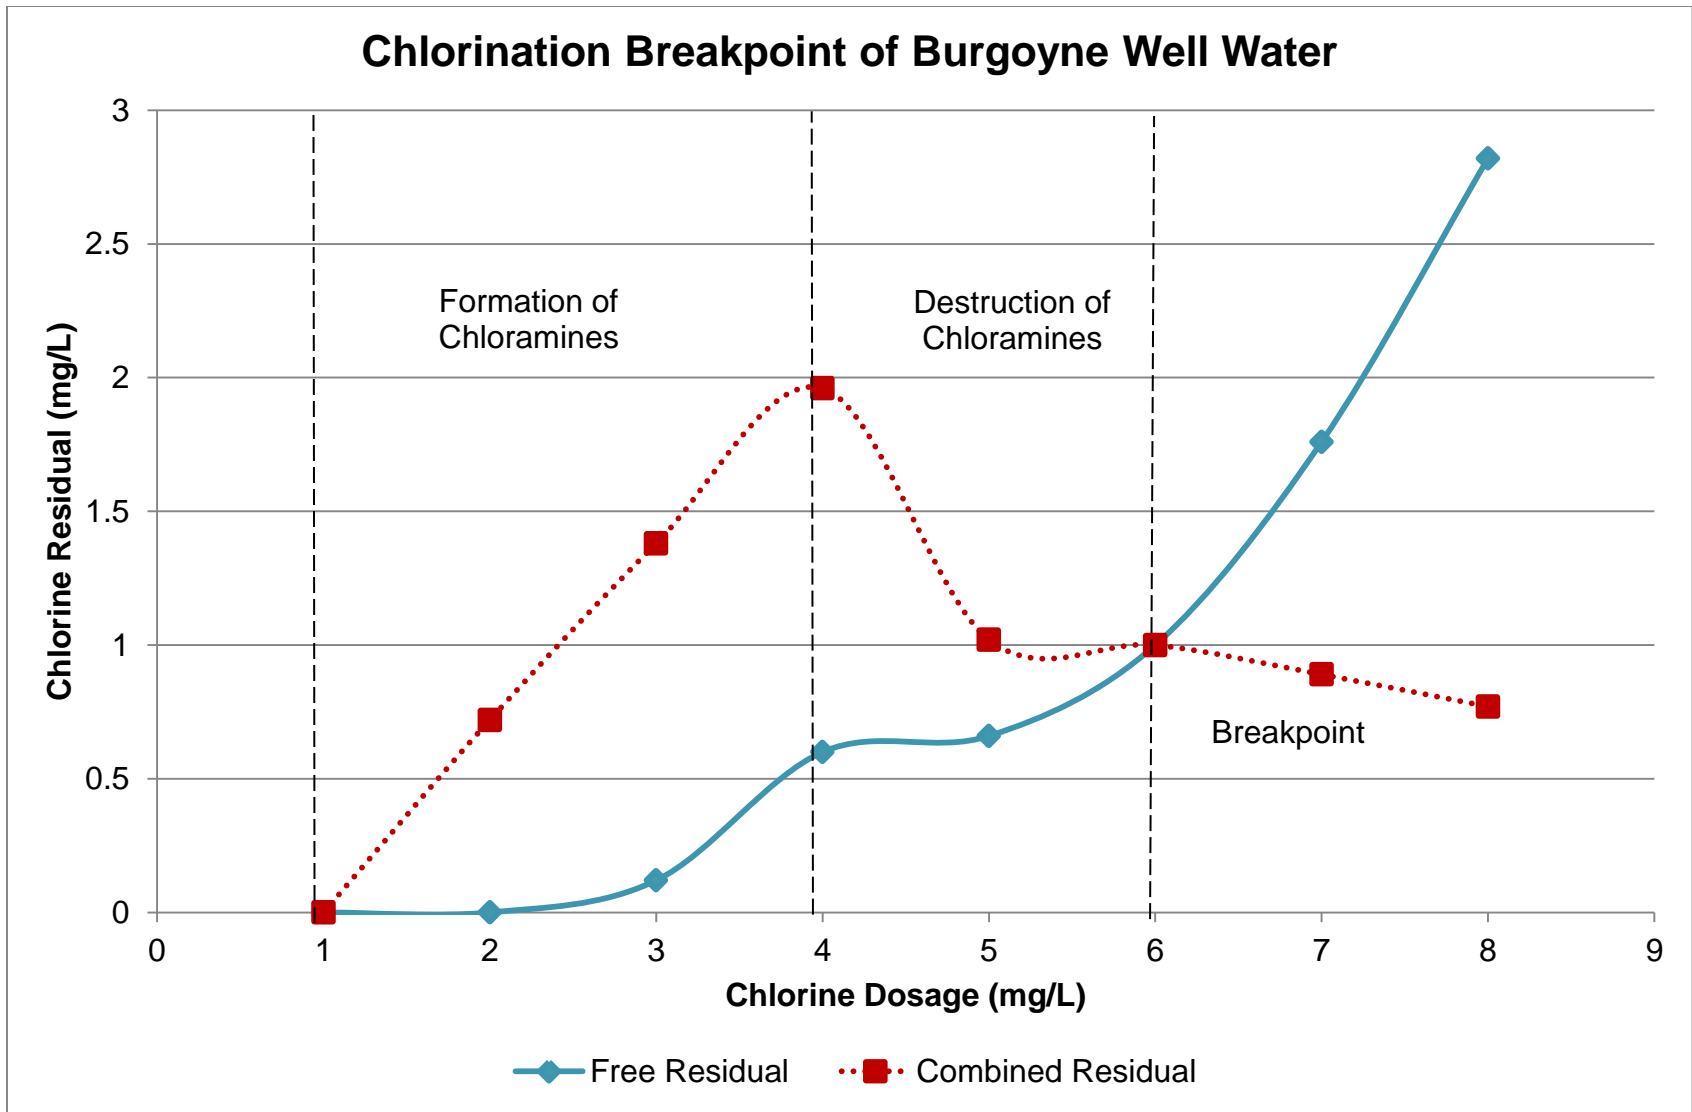
Figure 6. Bench: Objective 3 (Rep. 1)

The presence of ammonia at an average of 0.43 mg/L appears to affect the dose of chlorine based on the results from Tables 5 and 6, illustrated in Figures 6 and 7. A chlorine breakpoint curve was observed as it follows the typical relationship when graphed.

As the graph suggests, ammonia reacts with the chlorine dose to form chloramines between doses of ~1-4 mg/L and ~1-5 mg/L as indicated in Figures 6 and 7 respectively. As the chlorine dose increases beyond the formation stage, the combined residual decreases due to the destruction of chloramines. Breakpoint was achieved at doses of ~6 mg/L and ~6.8 mg/L as indicated in Figures 6 and 7 respectively, where the combined residual and free residual intersect and begin to increase in difference. This graph can be used to understand the demands present in the source water and can assist in planning a disinfection strategy for the system. .

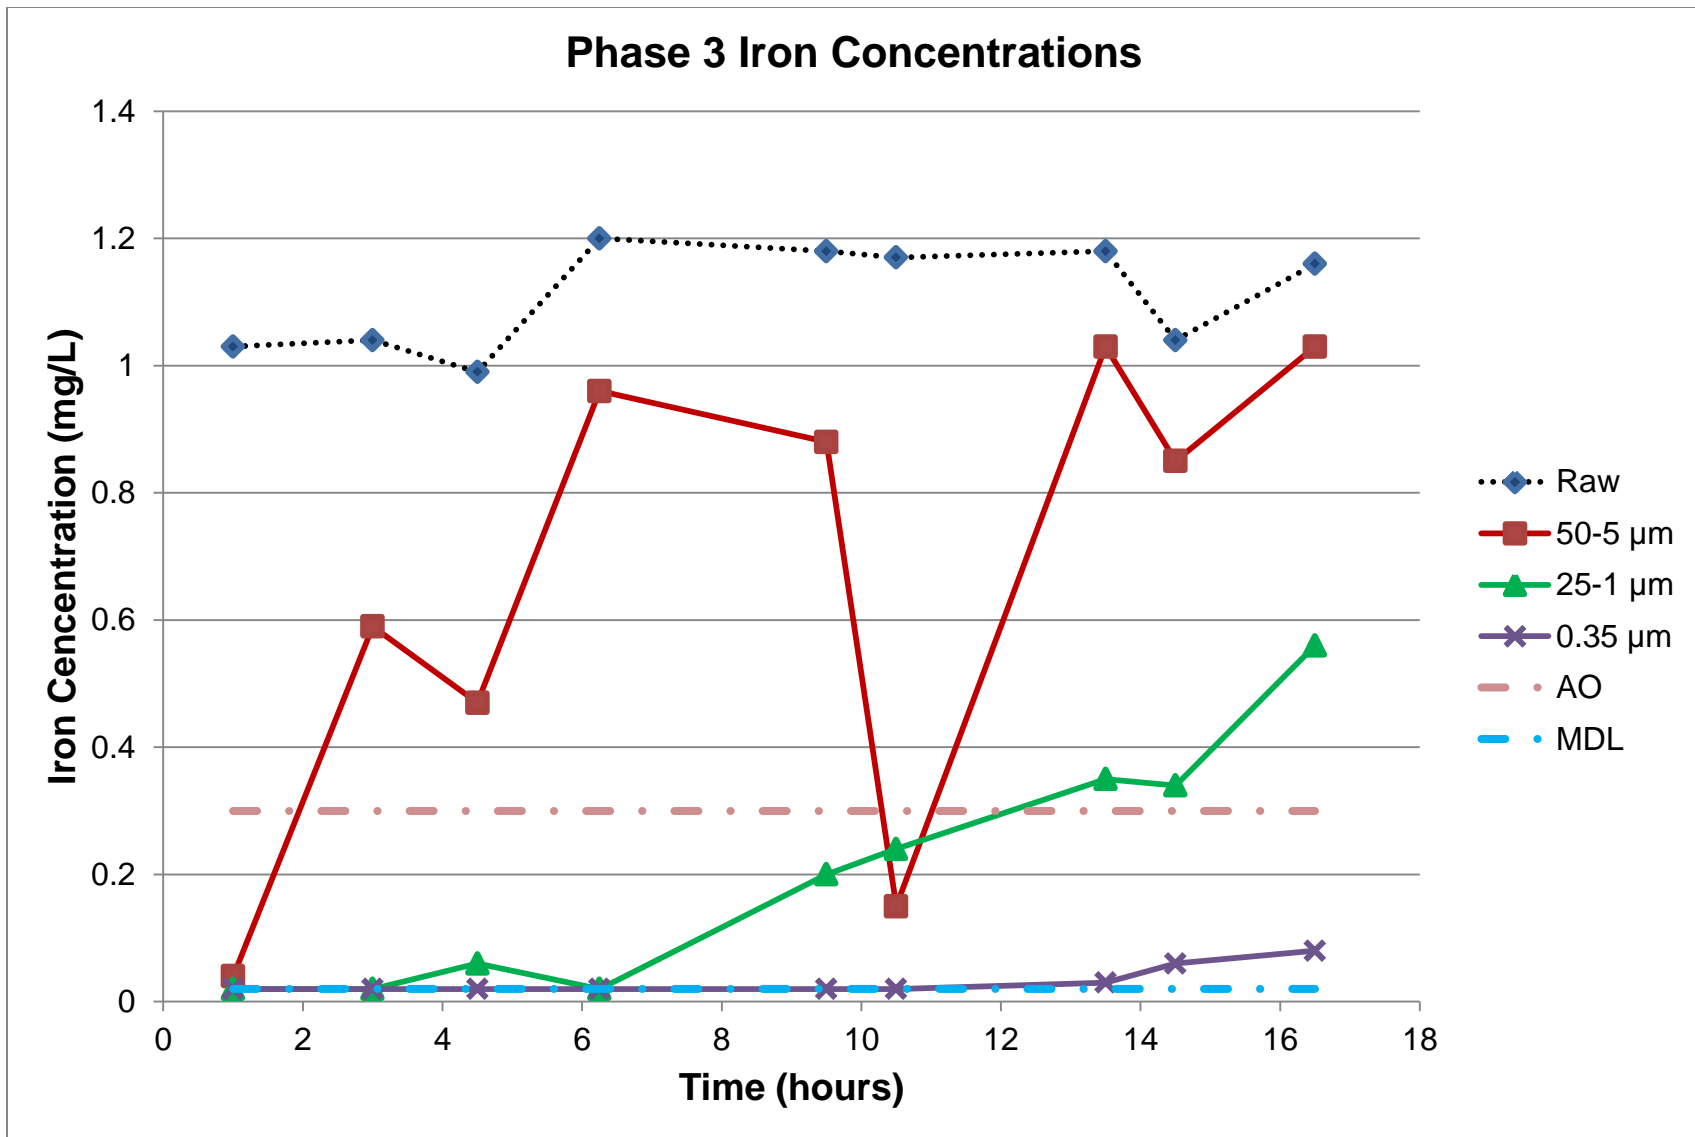
Figure 10. Pilot: Phase 3 Objective 1a

The 50-5 µm and 25-1 µm dual gradient nominal depth cartridge filters followed by the 0.35 µm surface pleated nominal cartridge filter removed iron below the MDL (Figure 10) during the life of the filters. Additionally, they were able to treat over twice the volume observed in phases 1 and 2 before experiencing a similar loss in pressure performance (Figure 11). The average particle size loading for each filter (Figure 18) can be used to estimate the life expectancy if larger filters are used.

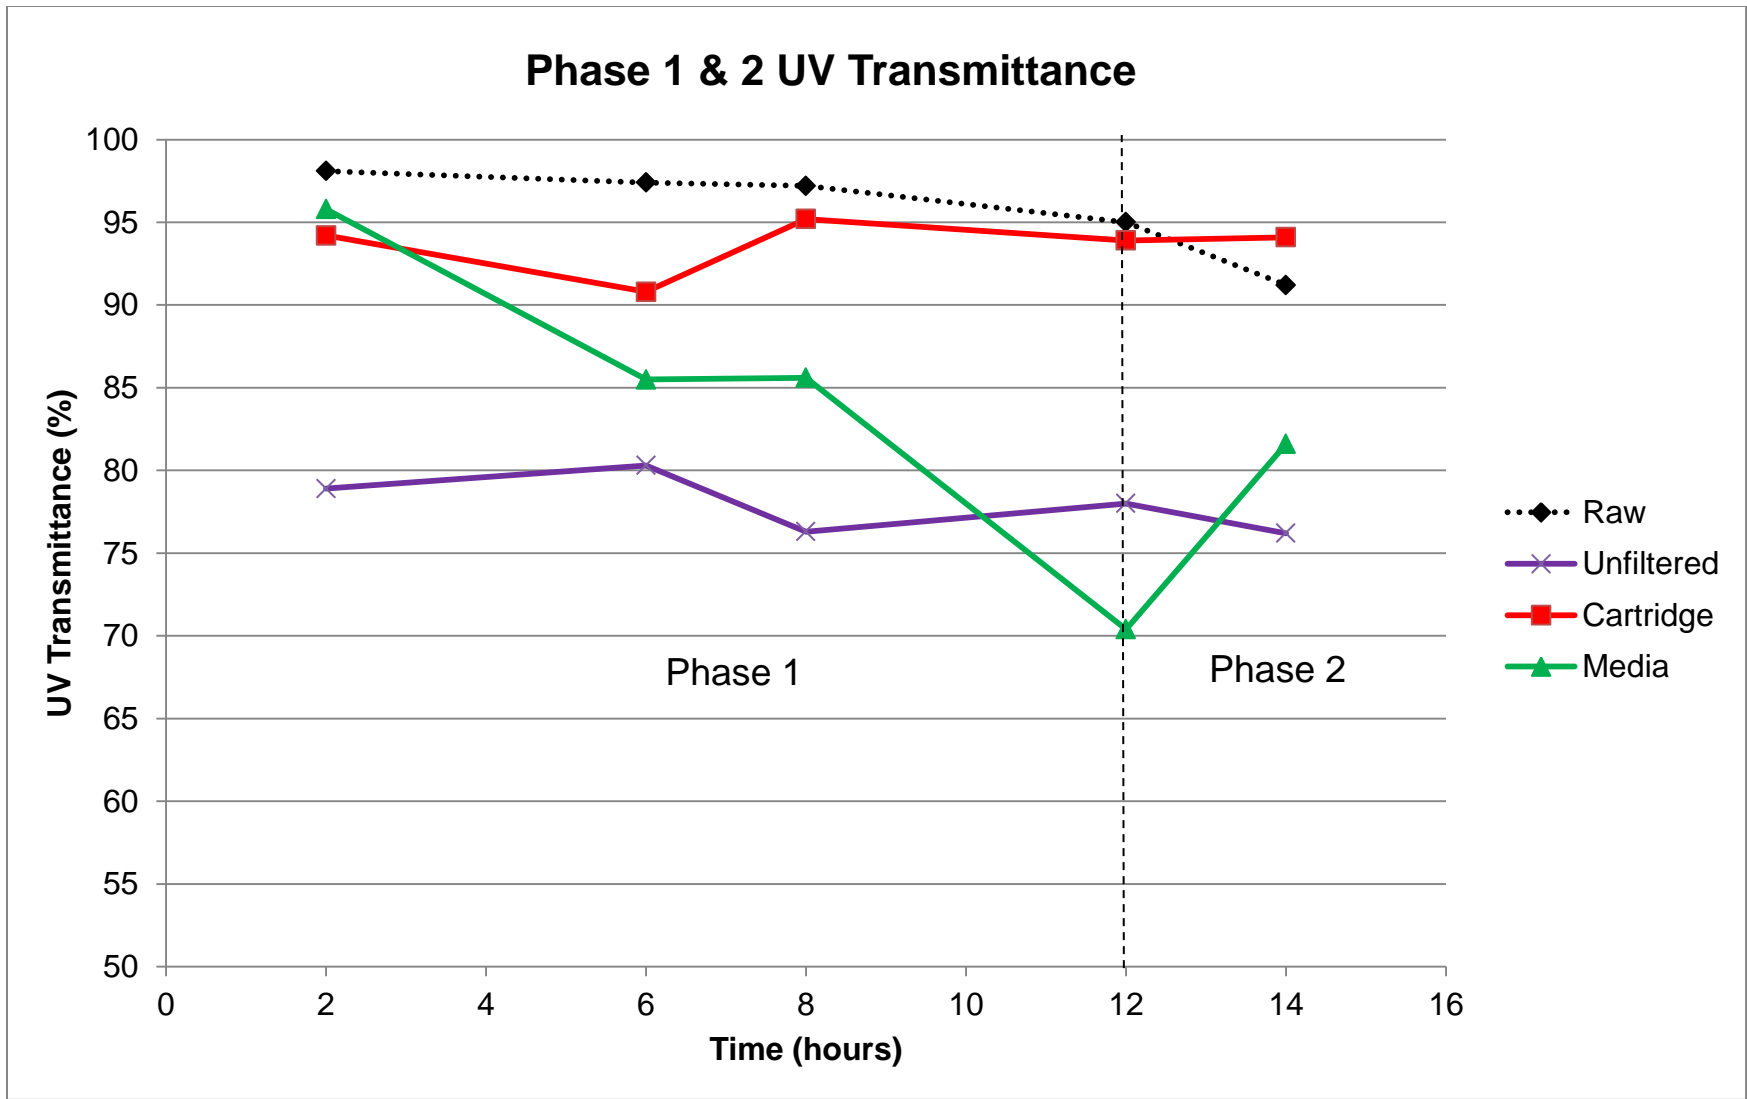
Figure 15. Pilot: Phase 1 & 2 Objective 5a

The free chlorine residual target was ~1.2 –1.5 mg/L after filtration and was monitored continuously with free chlorine probes (Figure 15). To achieve this concentration, the target chlorination dose added was approximately ~ 7.0-7.5 mg/L. This value was estimated using a combination of the breakpoint curve (Figure 7) and the point of entry (POE)/unfiltered chlorine residuals (Figure 16) as the sodium hypochlorite stock was diluted and found to vary depending on mixing.

The removal of aeration was the probable cause of the stabilization of UV transmittance readings due to air bubble interference presented during media filtration (Figure 15). The pH remained within the OG during phase 2 with minimal variation from phase 1 (Figure 16). The turbidity followed the expected trend as the cartridge filter effluent yielded the lowest turbidity followed by media filtration, raw/untreated, and the highest turbidity being chlorinated-unfiltered due to the precipitated iron (Figure 17).

The pH remained within the OG and was consistent during phase 1 with minimal variation (Figure 18). The turbidity values followed the expected trend as the cartridge filter effluent yielded the lowest turbidity followed by media filtration, raw/untreated, and the highest being post-chlorination oxidation (unfiltered) due to the precipitated iron (Figure 19). UV transmittance followed a similar trend with cartridge filtration, monomedia filtration and raw/untreated being lower than the chlorinated, unfiltered water due to the presence of precipitated iron (Figure 17). Variation in the UV transmittance data for the media filtration train was likely due to the production of air bubbles during aeration that interfered with the analyzer. It also appeared that the filters had a high chlorine demand initially that decreased over time (Figure 15 & 16).

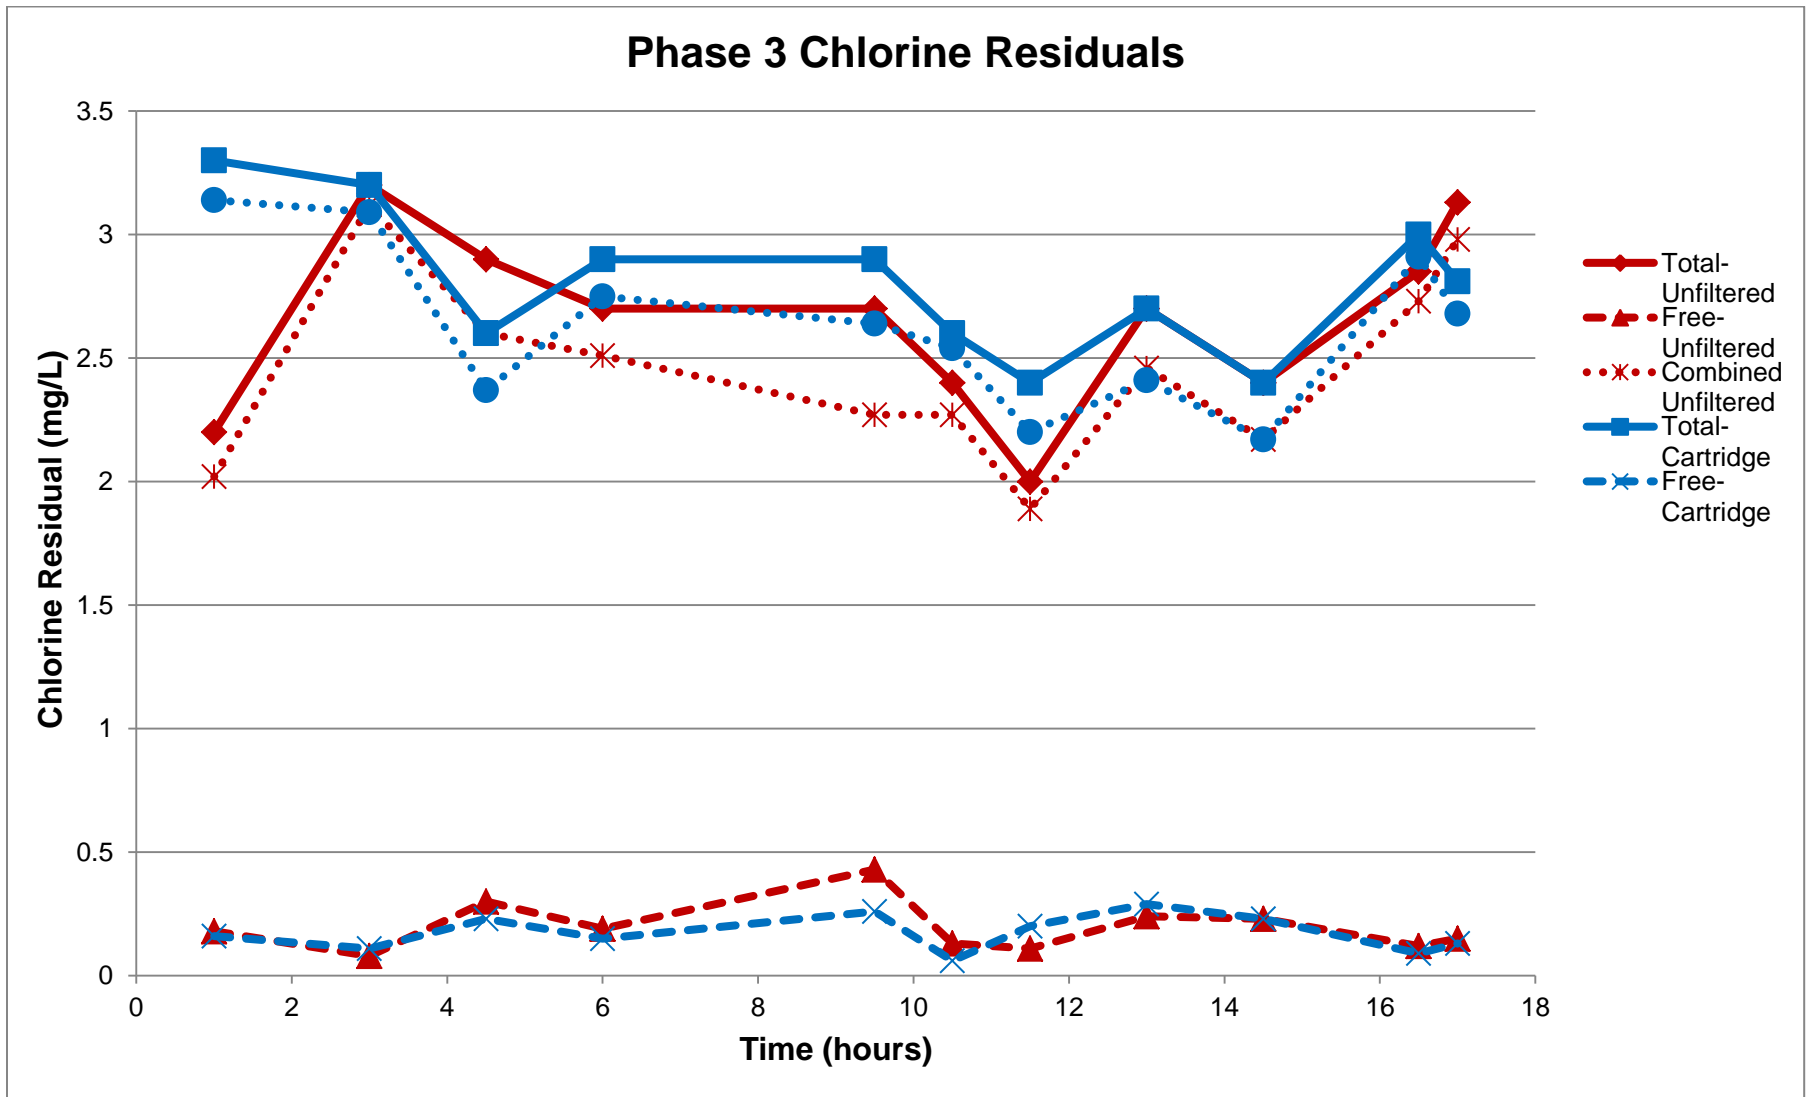
Figure 19. Pilot: Phase 3 Objective 4

The chlorine dose used to maintain a typical combined chlorine residual did not produce disinfection by-products above the MACs (Figure 19).

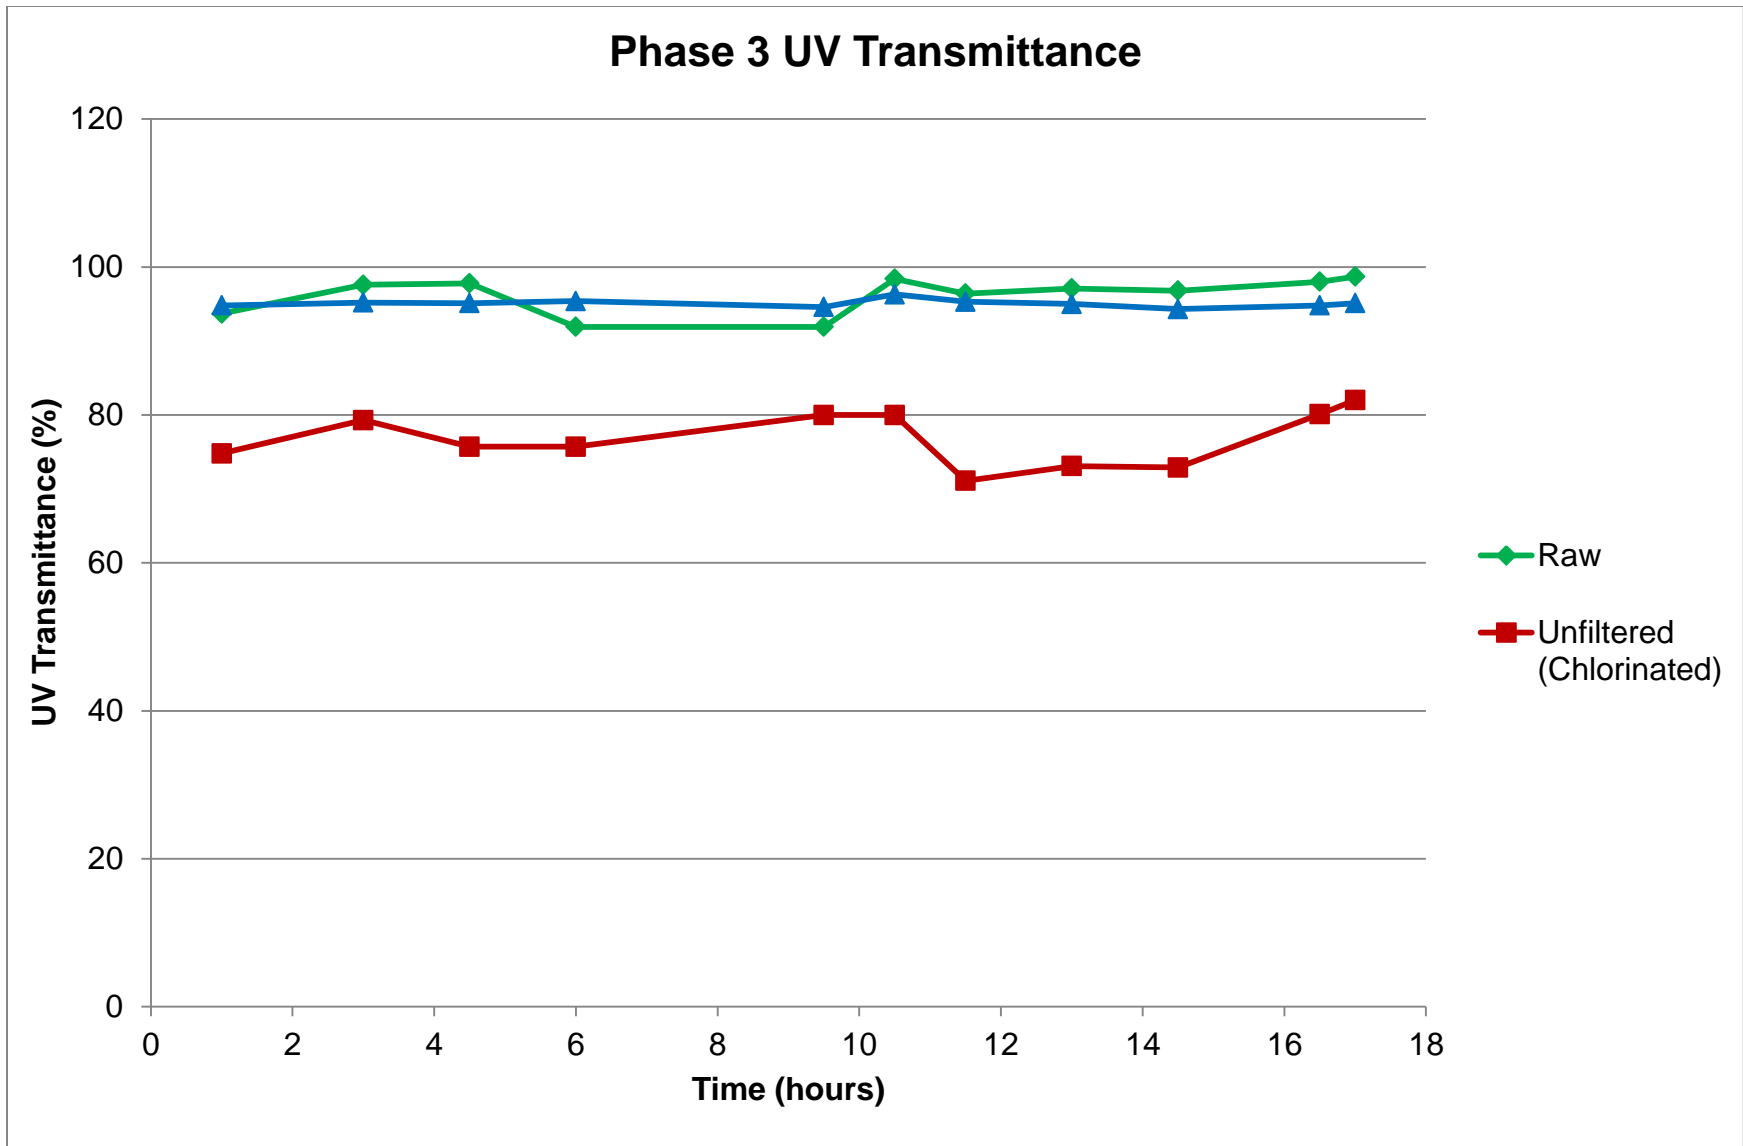
Figure 20. Pilot: Phase 3 Objective 5a

UV transmittance (Figure 20), pH (Figure 21), and turbidity (Figure 22) were similar to that recorded during the first two phases, further suggesting that precipitated iron is the primary influence in readings of elevated turbidity and reductions in UV transmittance.
