Annual Progress Report (2023) - Arran Landfill

Municipality of Arran-Elderslie
ECA No. 0441-4J2HV8 and No. 7585-8QKL5Q

GMBP File: M-1174

March 2024

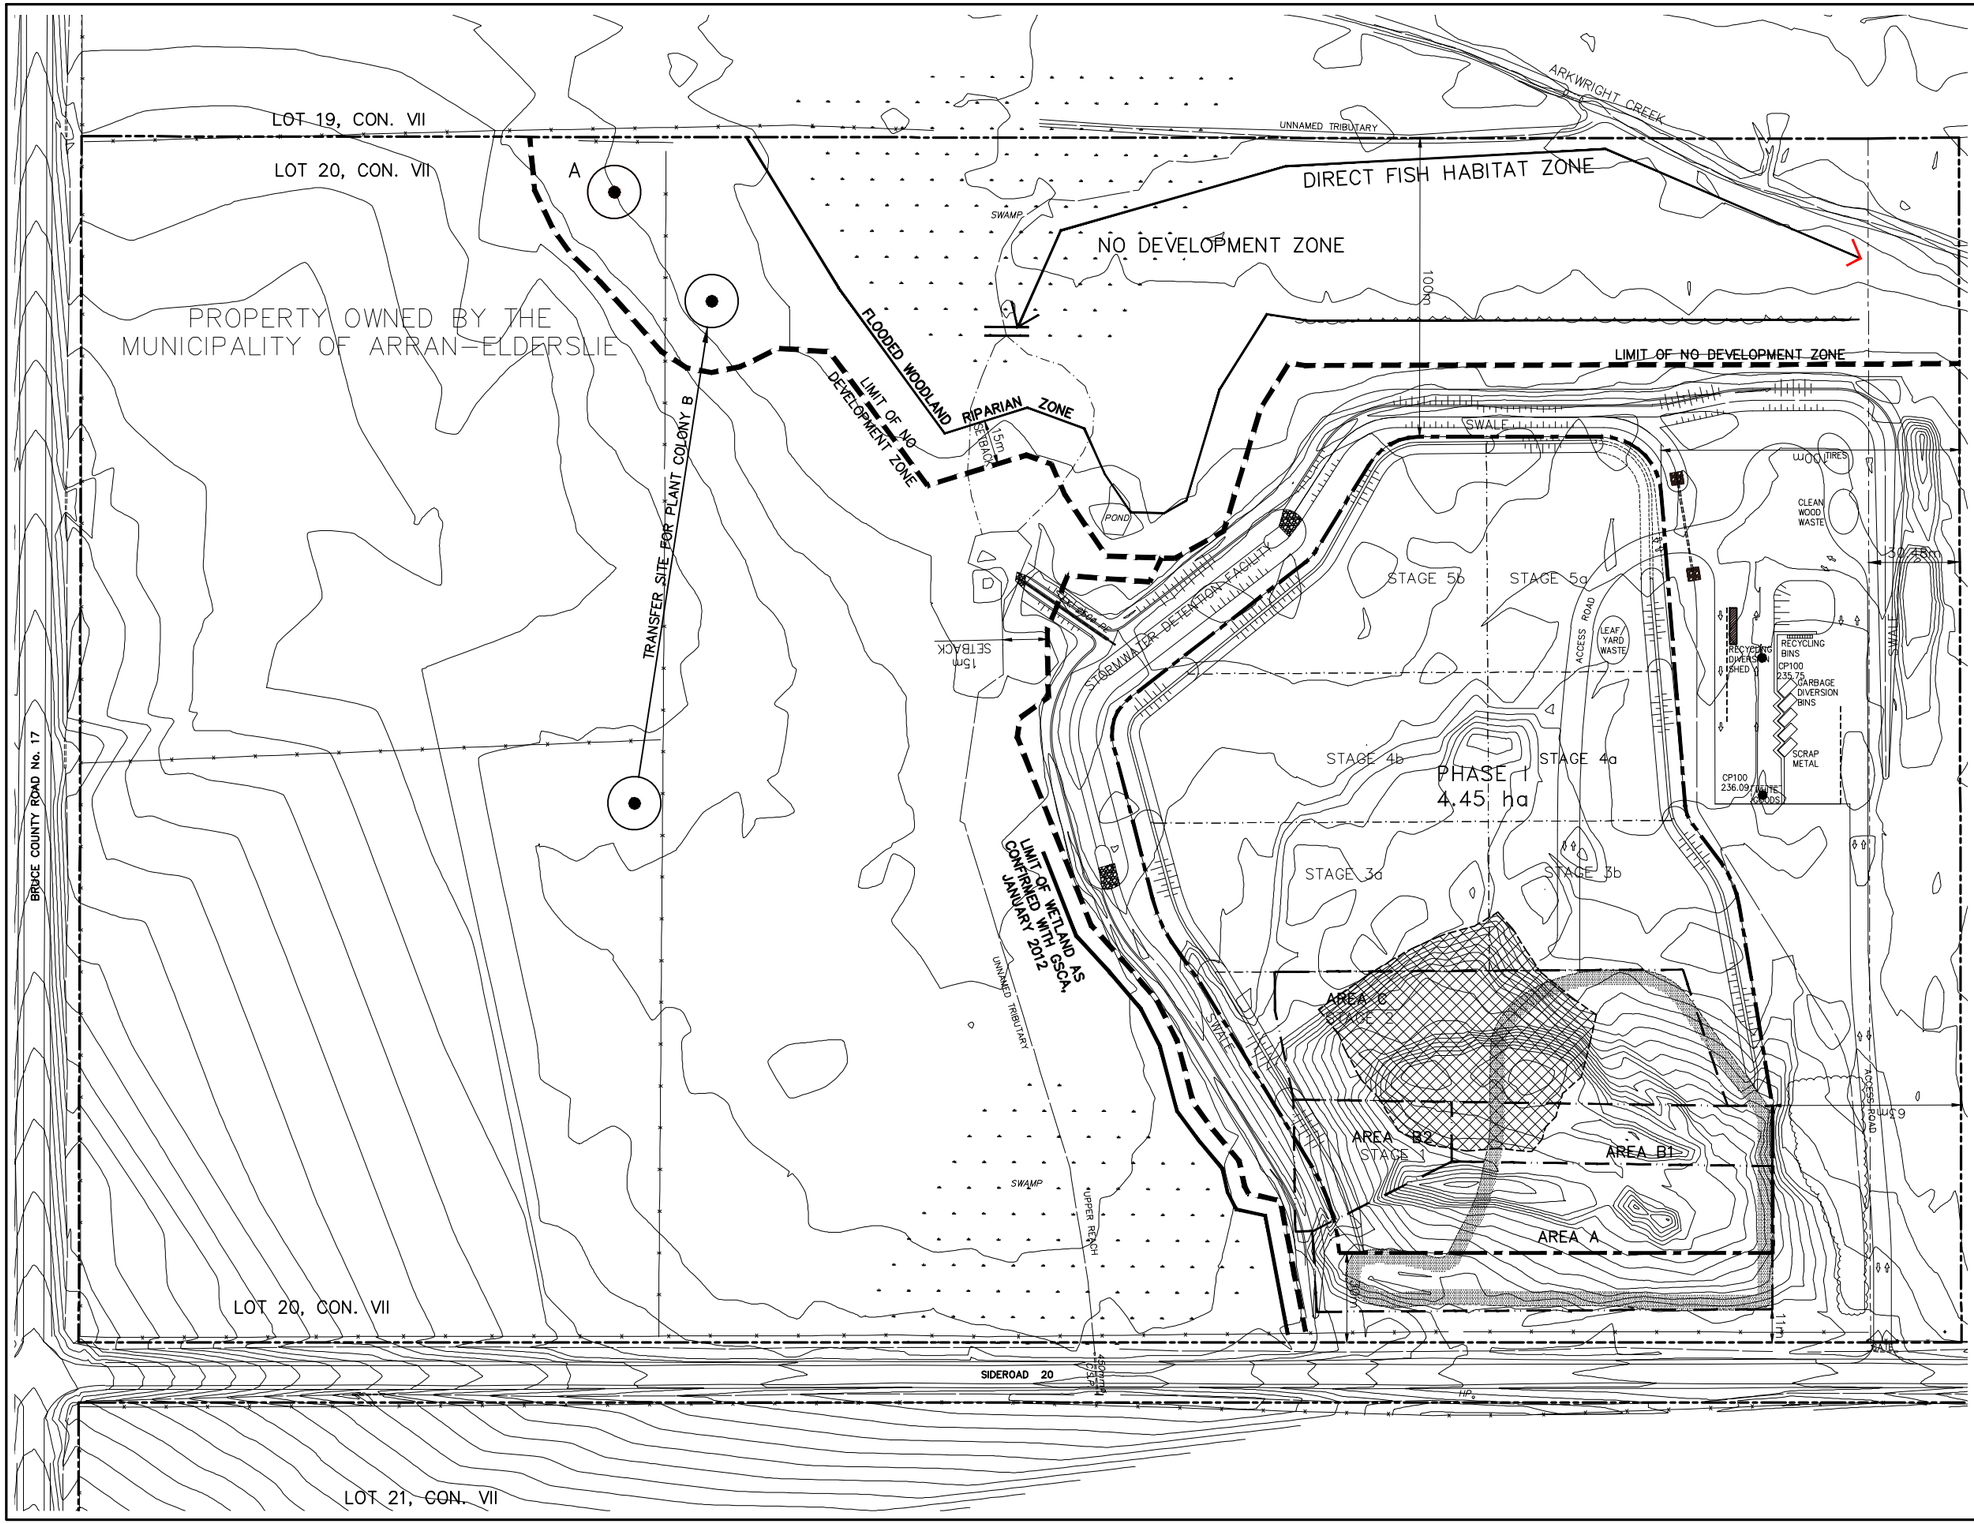
Figure No. 3

Leachate is produced when surface water percolates down through refuse and into the groundwater. In 2001, final cover was applied to the northern portion of the landfill and an interim cover was applied to the remainder of the landfill mound, temporarily closing the site (Figure 3). Additional final cover and topsoil placement was completed within the historically landfilled areas in 2016, particularly along the eastern slope. To date, the northern slope of the old fill area and the eastern slope have been capped and closed out. It is anticipated that these measures will reduce infiltration and leachate production in these areas of the landfill.

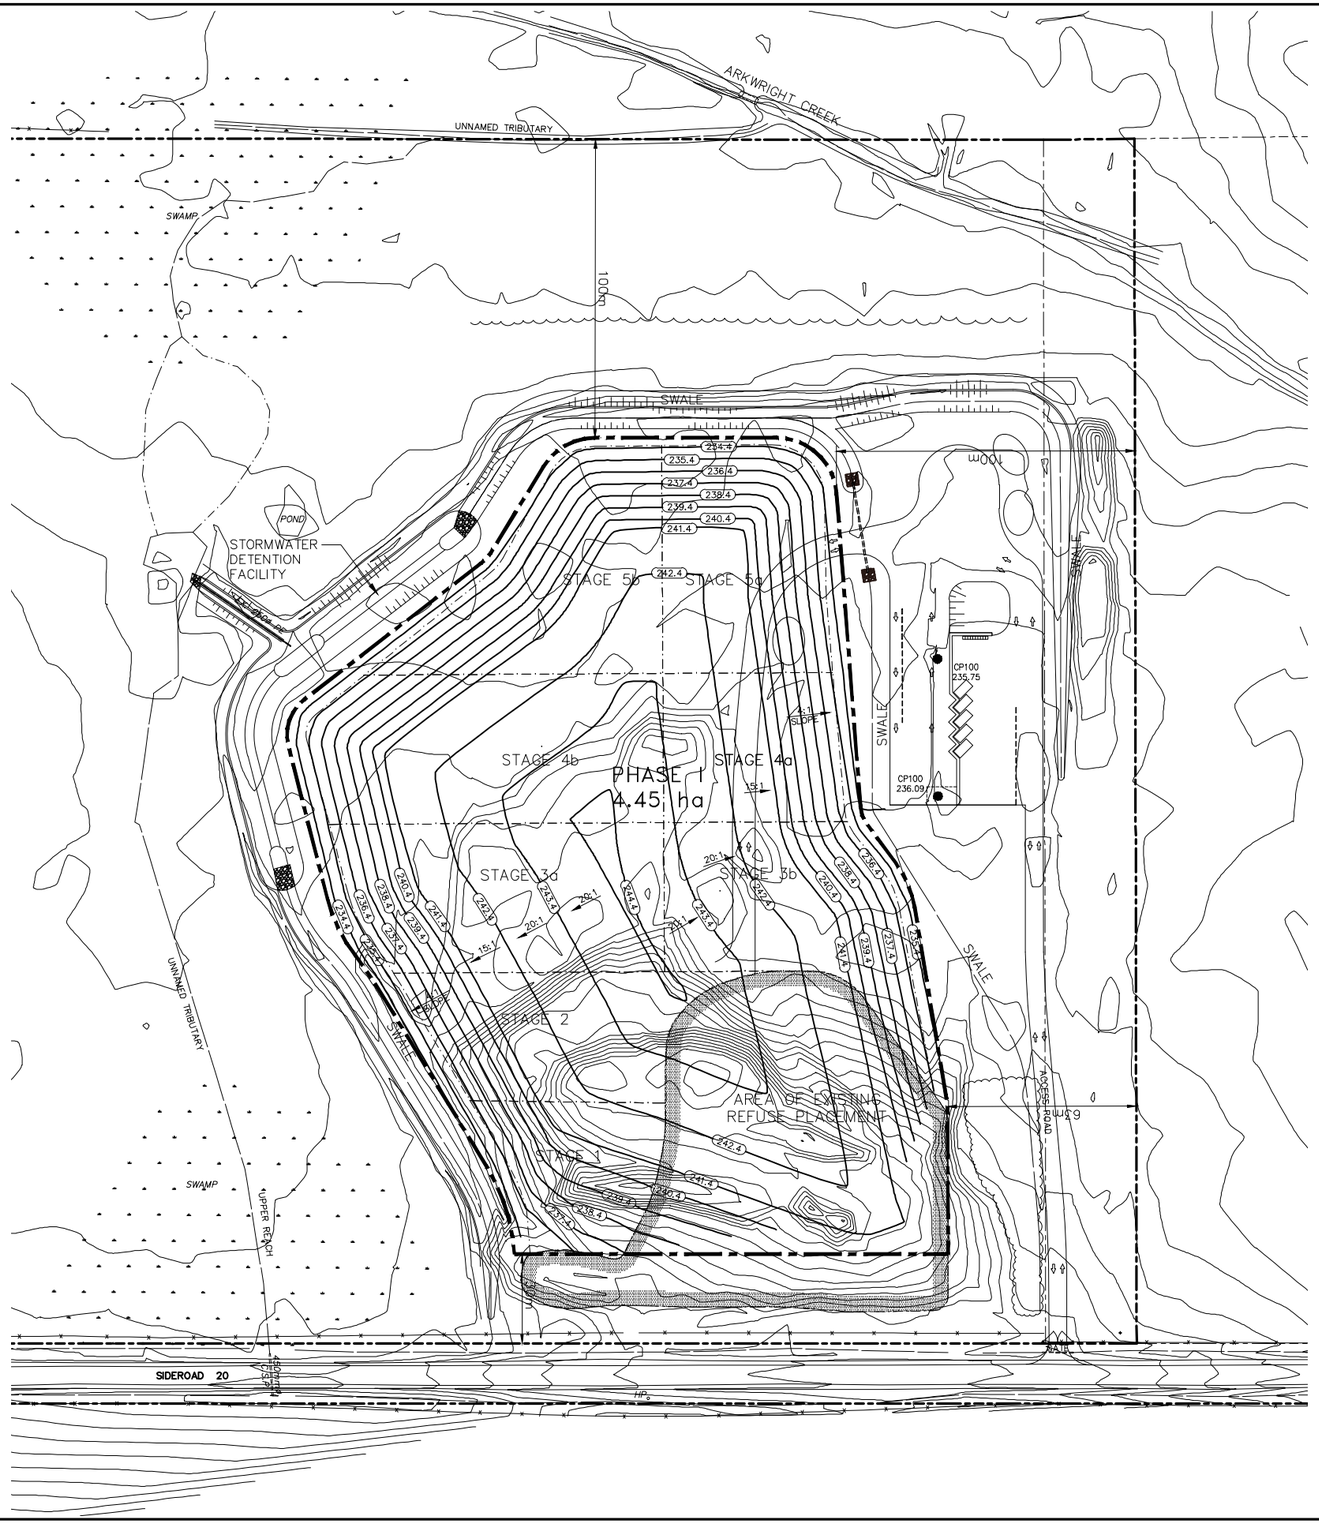
Figure No. 5

Groundwater quality along the eastern boundary of the fill area is currently monitored at wells TW-11D, TW-15, TW-15D and TW-27. These wells are located to the east and along the Lot 20/21 roadway adjacent to the landfill site (Figure 5).

In conjunction with the resumption of operations at the Arran Landfill Site in 2012, the Municipality acquired an additional 30 meters of land extending along the northern property boundary to better facilitate landfill operations and to extend the buffer area to the north. This was equivalent to an additional area of 1.16 hectares. In order to address on-going MECP concerns pertaining to the adequacy of monitoring locations TW-4 and TW-8 (i.e., well construction), these wells were replaced in October 2016 with well couplet TW-25S/D and well TW-26, respectively. While TW-4 and TW-8 historically represented northerly compliance monitoring locations, the well replacements were installed approximately 30 to 40 meters to the north in order to more accurately and reliably access Site compliance along the adjusted northerly compliance limit, where shown on Figure 5. The borehole logs/well records are provided in Appendix C.

Arkwright Creek is located to the west of the Site and flows in a northerly direction across the northwest corner of the Site (Figure 5). Surface water quality is monitored at an upstream and downstream location within Arkwright Creek at SW-7 and SW-1, respectively. Based on the results, indicator parameter concentrations at SW-7, which represents the water quality prior to potential influence from the landfill, are similar to concentrations downstream of the landfill (i.e., at SW-1). Therefore, there is no evidence of landfill related impacts to Arkwright Creek.

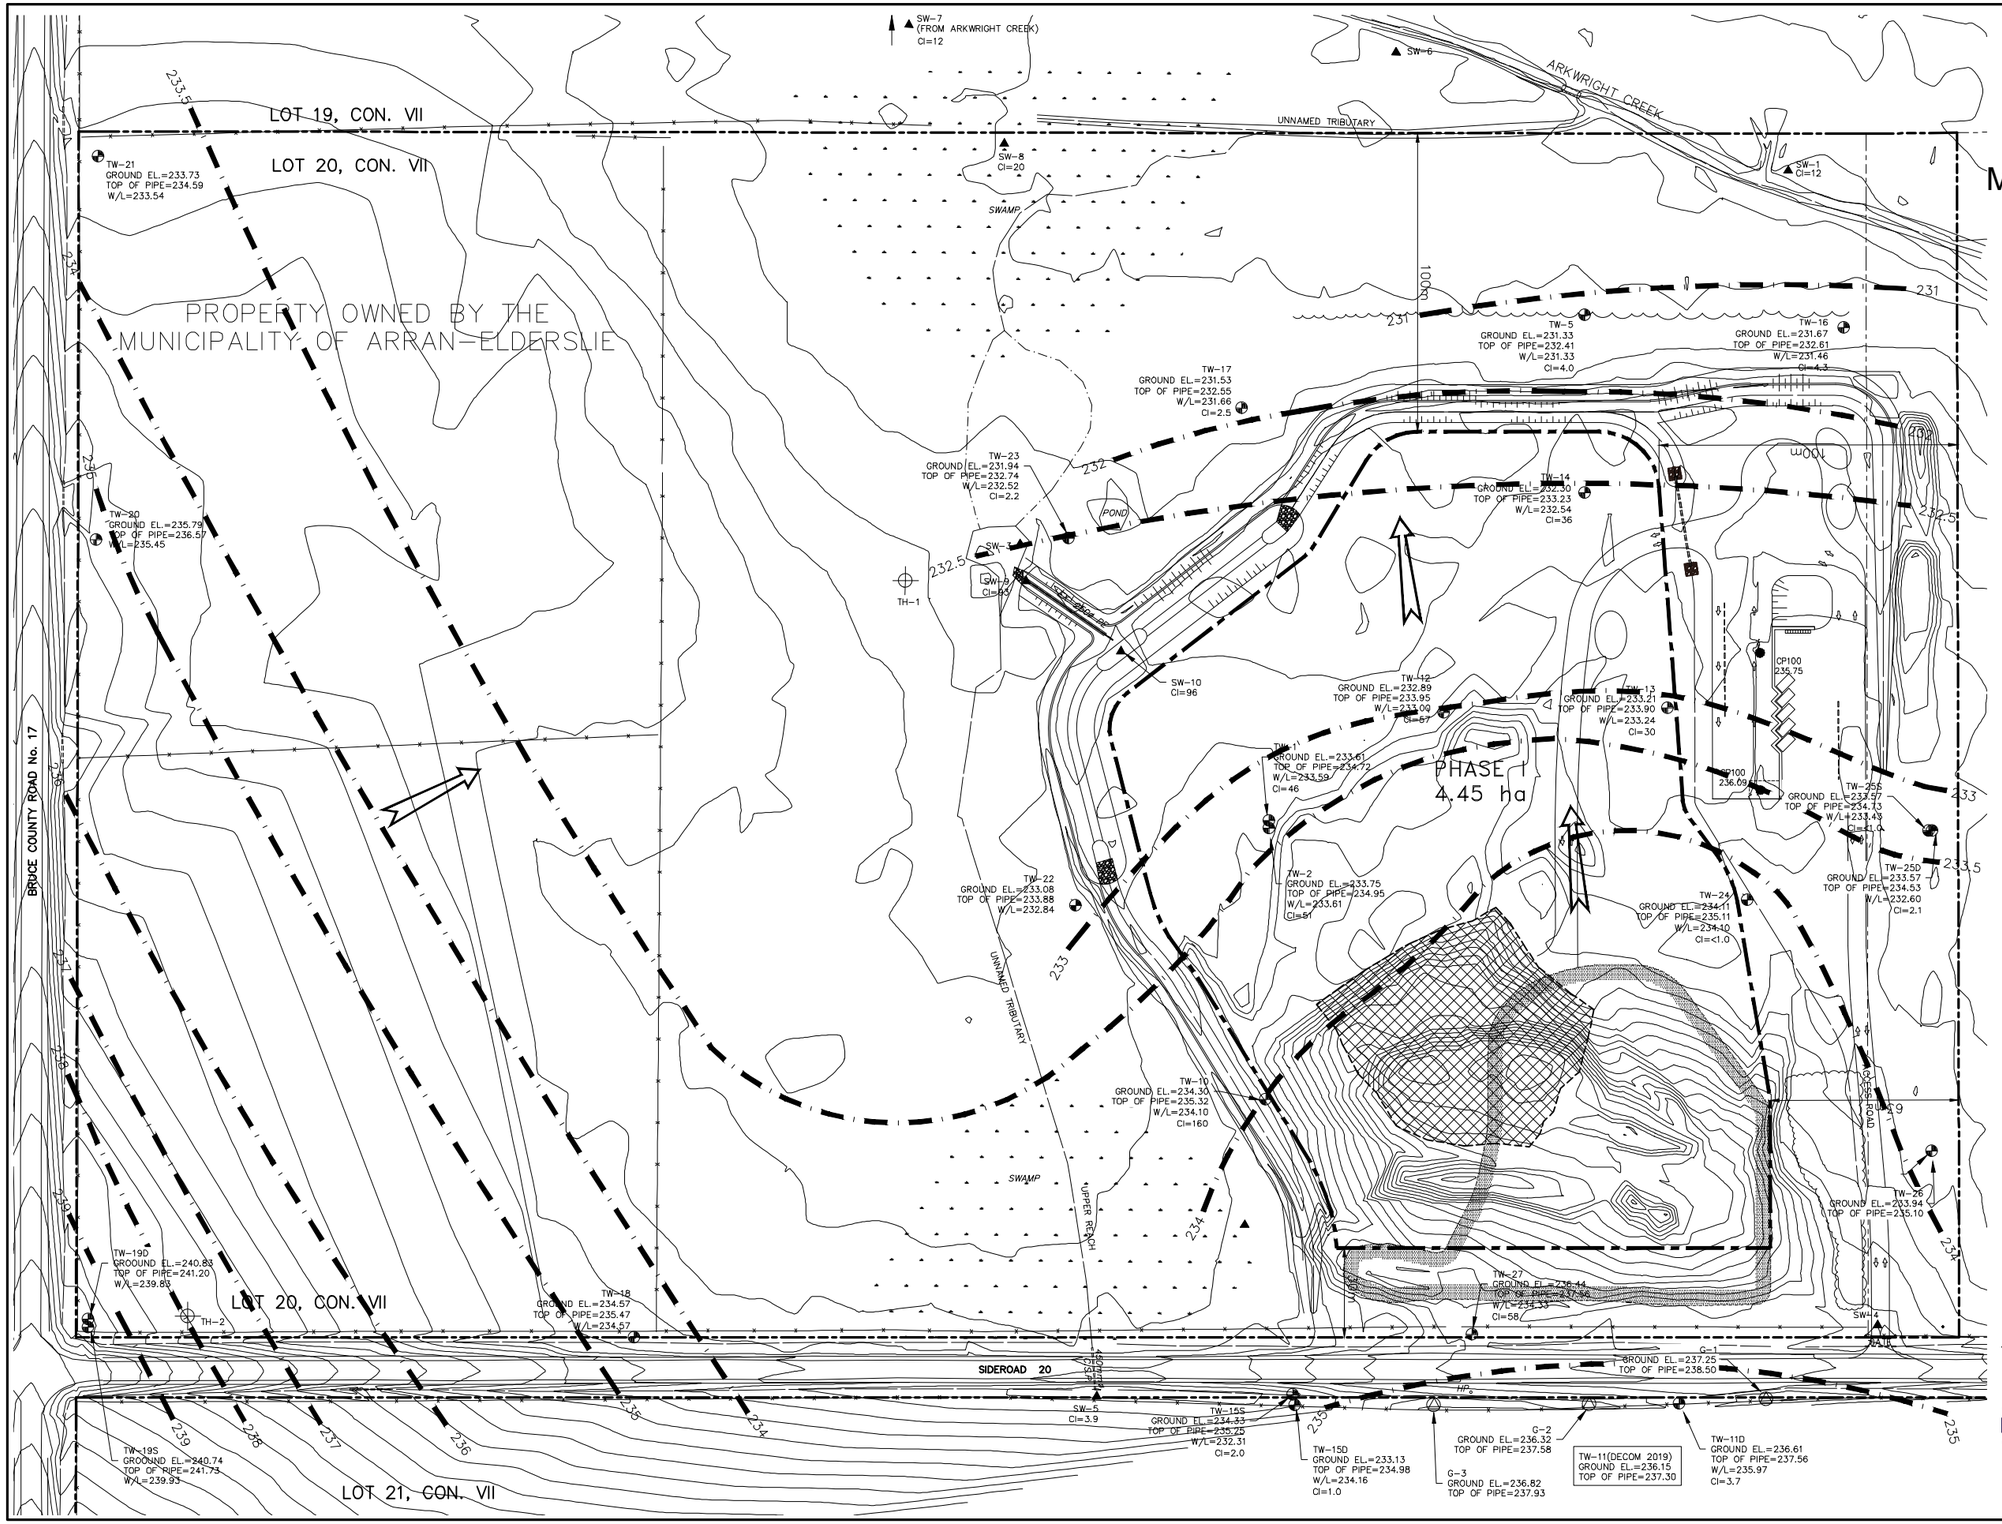
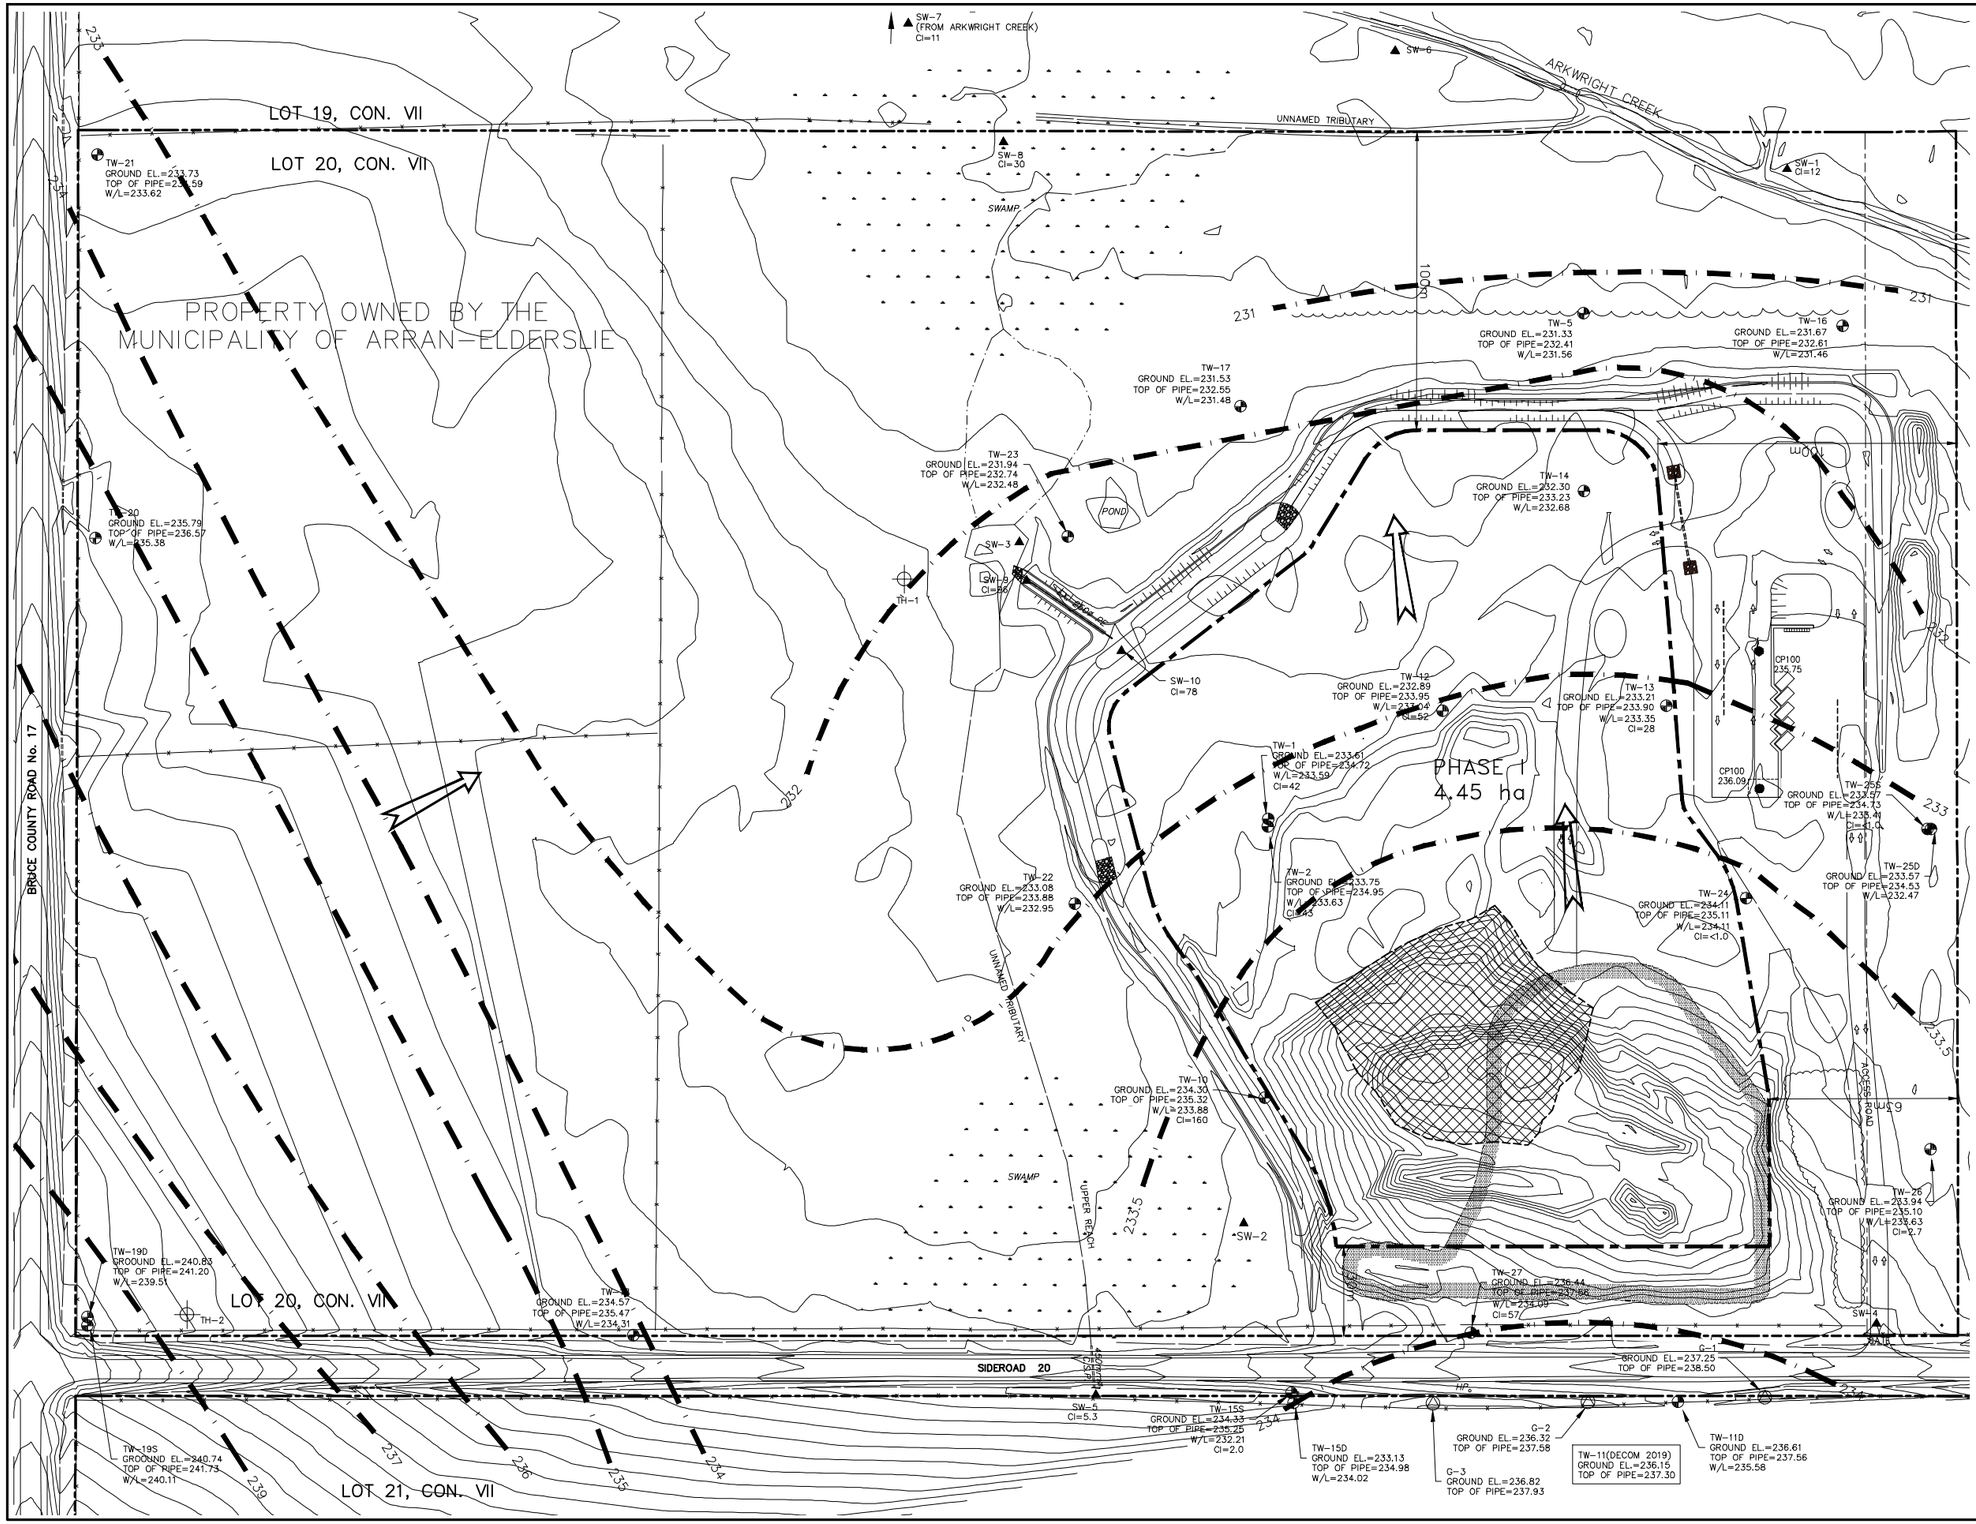
Figure No. 6

Based on the regional groundwater flow direction in this area of the Site which is generally to the south and west (Figures 6 and 7), the location of the recently active fill area of greater than 50 meters downgradient of TW-27, and the additional separation distance of approximately 10 m from the municipal road allowance, it is expected that further migration of landfill leachate-impacted groundwater in an easterly direction will be limited. Furthermore, with the placement of final cover along the entire Phase I eastern limit of fill, which was completed in 2016, it is anticipated that a decreasing concentration trend will develop over time, ultimately decreasing the magnitude and extent of influence to the east of the landfill. Currently, the concentration trends are stable to decreasing.

ii. Water level measurements at TW-11D, TW-15 and TW-15D and TW-27 indicate a local hydraulic gradient to the south along the east side of the municipal road allowance. Shallow groundwater that flows southerly is expected to re-route to the west along the path of convergence that is congruent with the centrally located stream (at the road crossing culvert location shown on Figures 6 and 7).

In summary, the leachate impacted groundwater is limited to the area directly beneath the landfill, the landfill perimeter, and west (downgradient) of the landfill to approximately 100m. Based on groundwater monitoring, the predominant direction of groundwater flow is to the west and southwest towards Arkwright Creek and the swampy depression. However, historical water level monitoring has indicated that a local hydraulic gradient from the west to the southeast (i.e., a radial flow component) due to groundwater mounding within the refuse pile exists, although on-going water level measurements at these monitoring locations suggests that the localized radial flow has decreased since the final cover was applied to the eastern slope of the landfill mound (Figures 6 and 7).

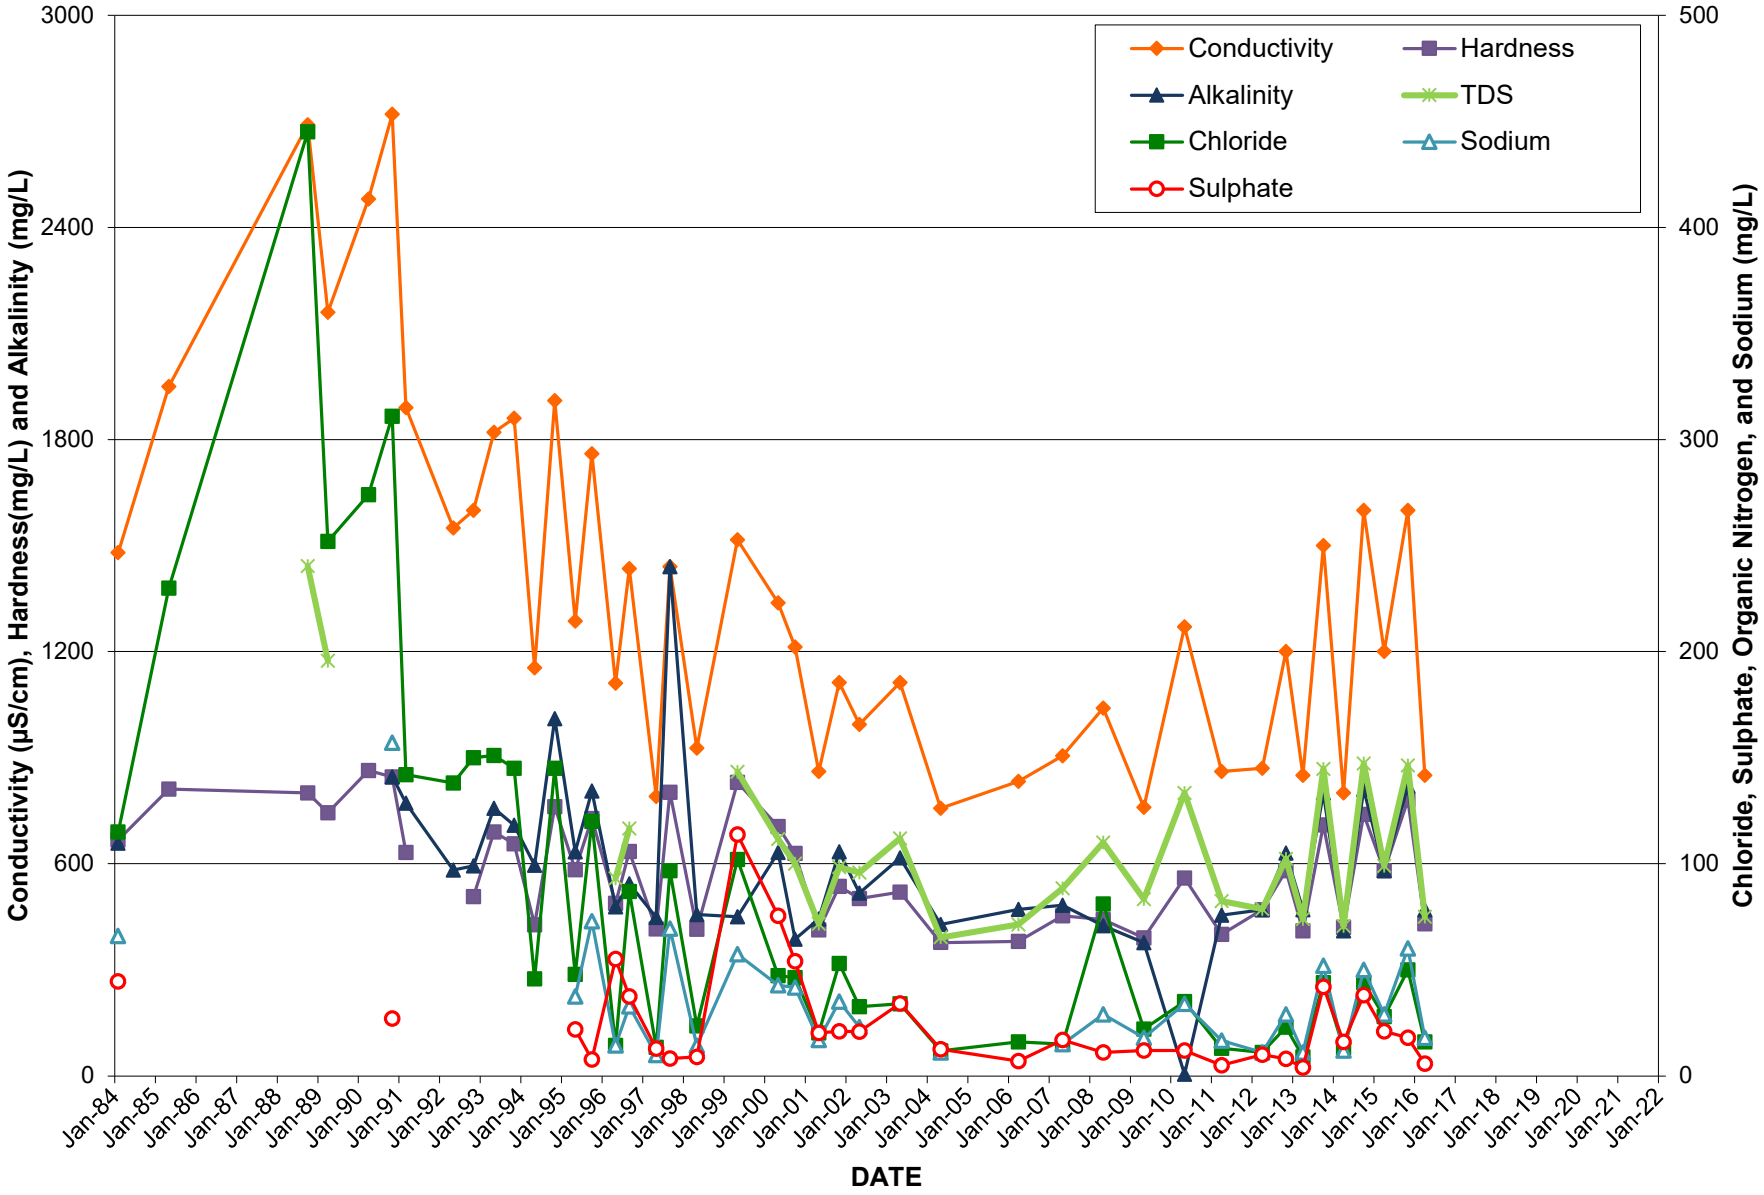
GROUNDWATER SAMPLING LOCATION: TW-9

Historically, TW-9 had shown evidence of leachate impacts although, consistent with its proximity to the fill area and the radial flow patterns identified, impacts were most notable before final and interim cover was applied to the surface of the fill area in 2000, upon temporary Site closure. As shown on the trend graph provided in Appendix E, since landfilling resumed at the Site in 2012, the concentrations of several indicator parameters exhibit a strong seasonal variation, with higher concentrations typically being measured in the fall. A similar seasonal variation trend was noted prior to temporary Site closure. Based on the combination of parameters noted, including sodium, chloride, hardness and alkalinity, it appears that this monitoring location was susceptible to groundwater quality influences from the landfilling activities.

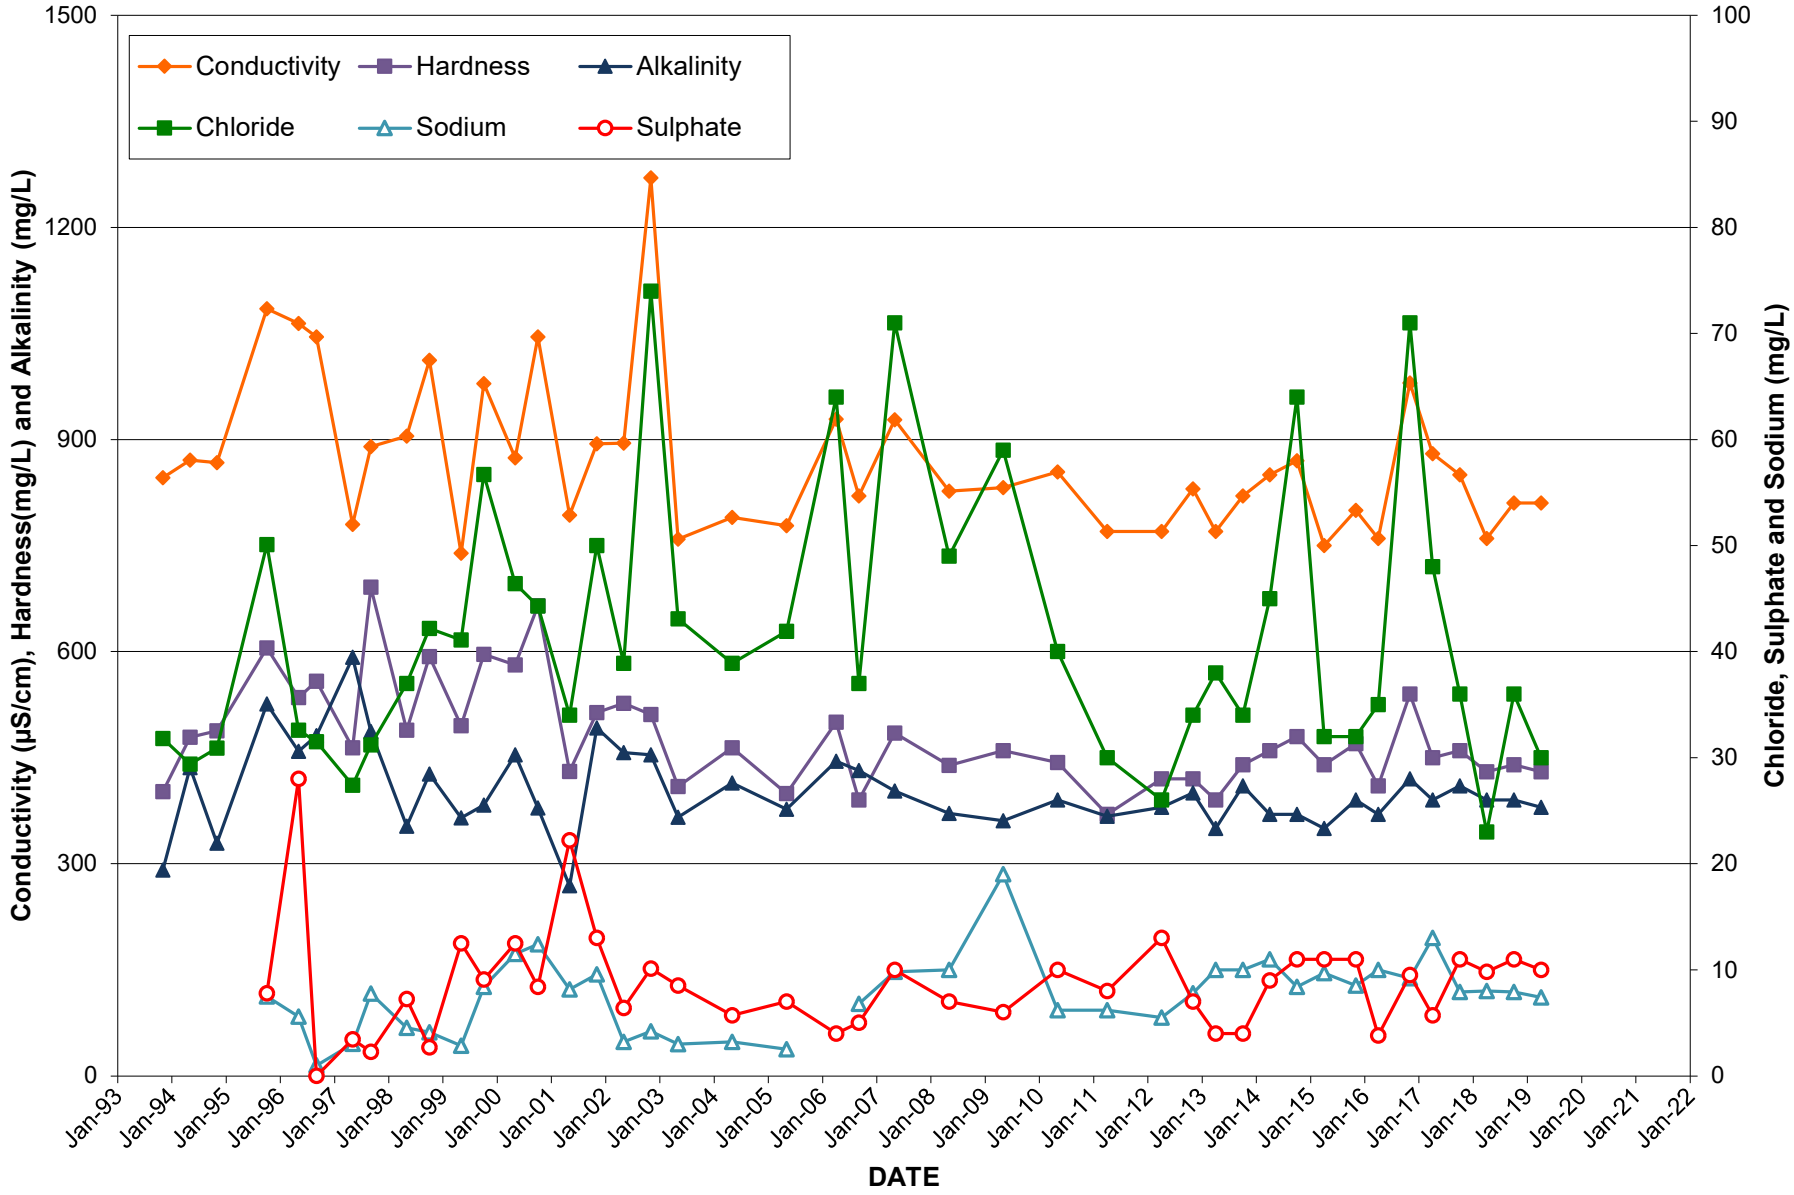
GROUNDWATER SAMPLING LOCATION: TW-11

Well TW-11 historically showed highly variable concentration trends, which were historically inferred to represent minor influence from leachate impacted groundwater. Chloride concentrations averaged approximately 40 mg/L at this location. In 2012, an additional well was installed adjacent to TW-11 (i.e., TW-11D). In contrast, the groundwater quality reported at well TW-11D generally demonstrates stable concentration trends with lower concentrations of leachate indicator parameters. Based on the inconsistent groundwater quality results noted at this well couplet, and questionable well integrity, decommissioning well TW-11 was recommended by the MECP in correspondence dated July 16, 2019 (Appendix B). Monitoring well TW-11 was decommissioned in July 2019.

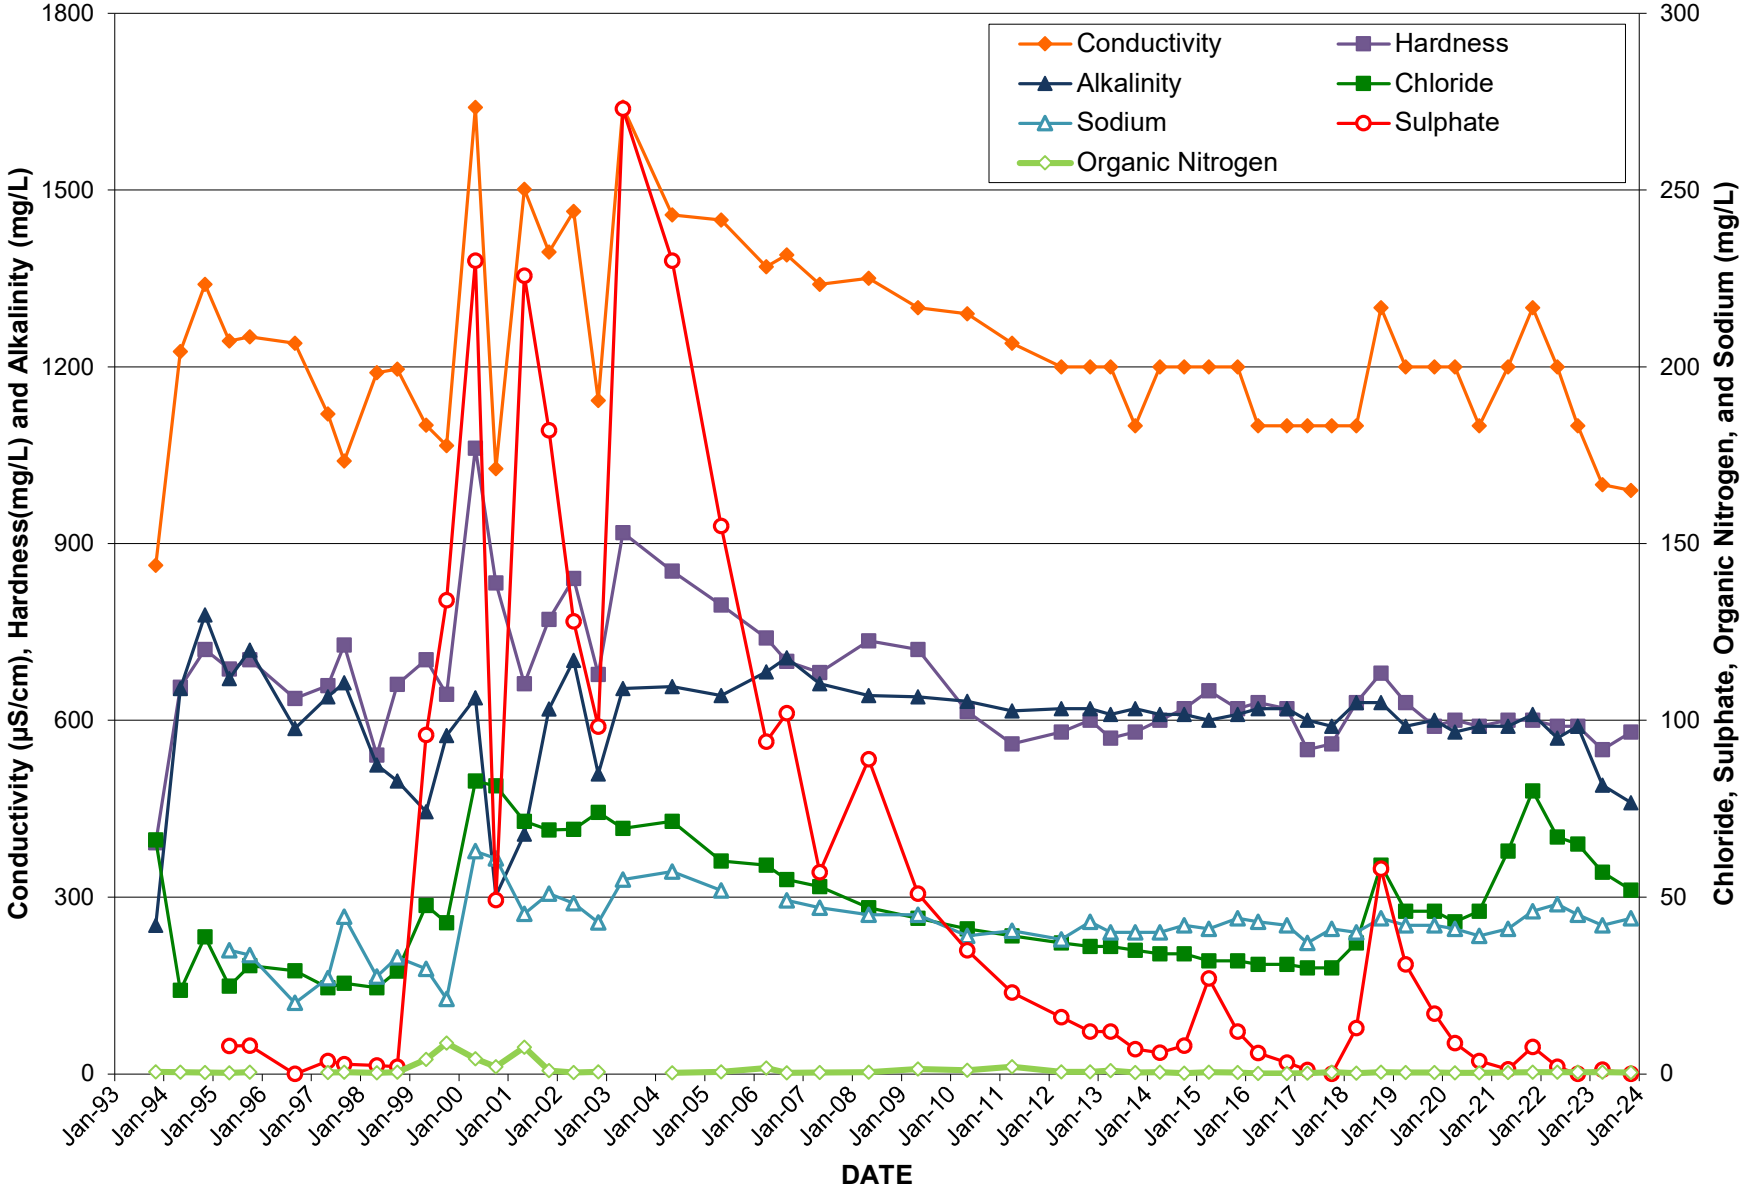
GROUNDWATER SAMPLING LOCATION: TW-12

Monitoring has shown local changes to groundwater chemistry (relative to background) directly west of the landfill with the highest concentrations of indicator parameters historically found at TW-12, located approximately 100 meters downgradient of the western limit of the landfill footprint. At TW-12 and TW-13, several indicator parameters including hardness, TDS, and alkalinity have typically exceeded the objective levels and ODWS aesthetic objectives. Chloride concentrations, although still below the objective level of 126 mg/L, have typically been highest in monitoring well TW-12 (averaging approximately 45 mg/L since 1993), with slightly elevated concentrations at well TW-13. The conductivity has also been consistently higher than background at these two downgradient monitoring wells.

The EM survey conducted by the MOE in 1997 correlates with these findings, showing that leachate-impacted groundwater was limited in extent to TW-12 and, to a lesser extent, well TW-13. However, it is noted that in the memorandum describing the results of the EM Survey, the potential leachate impacts noted at TW-12 and TW-13 were attributed to potential surface transport along ditches that formerly drained the site and settled in slight depressions near these two monitoring locations.

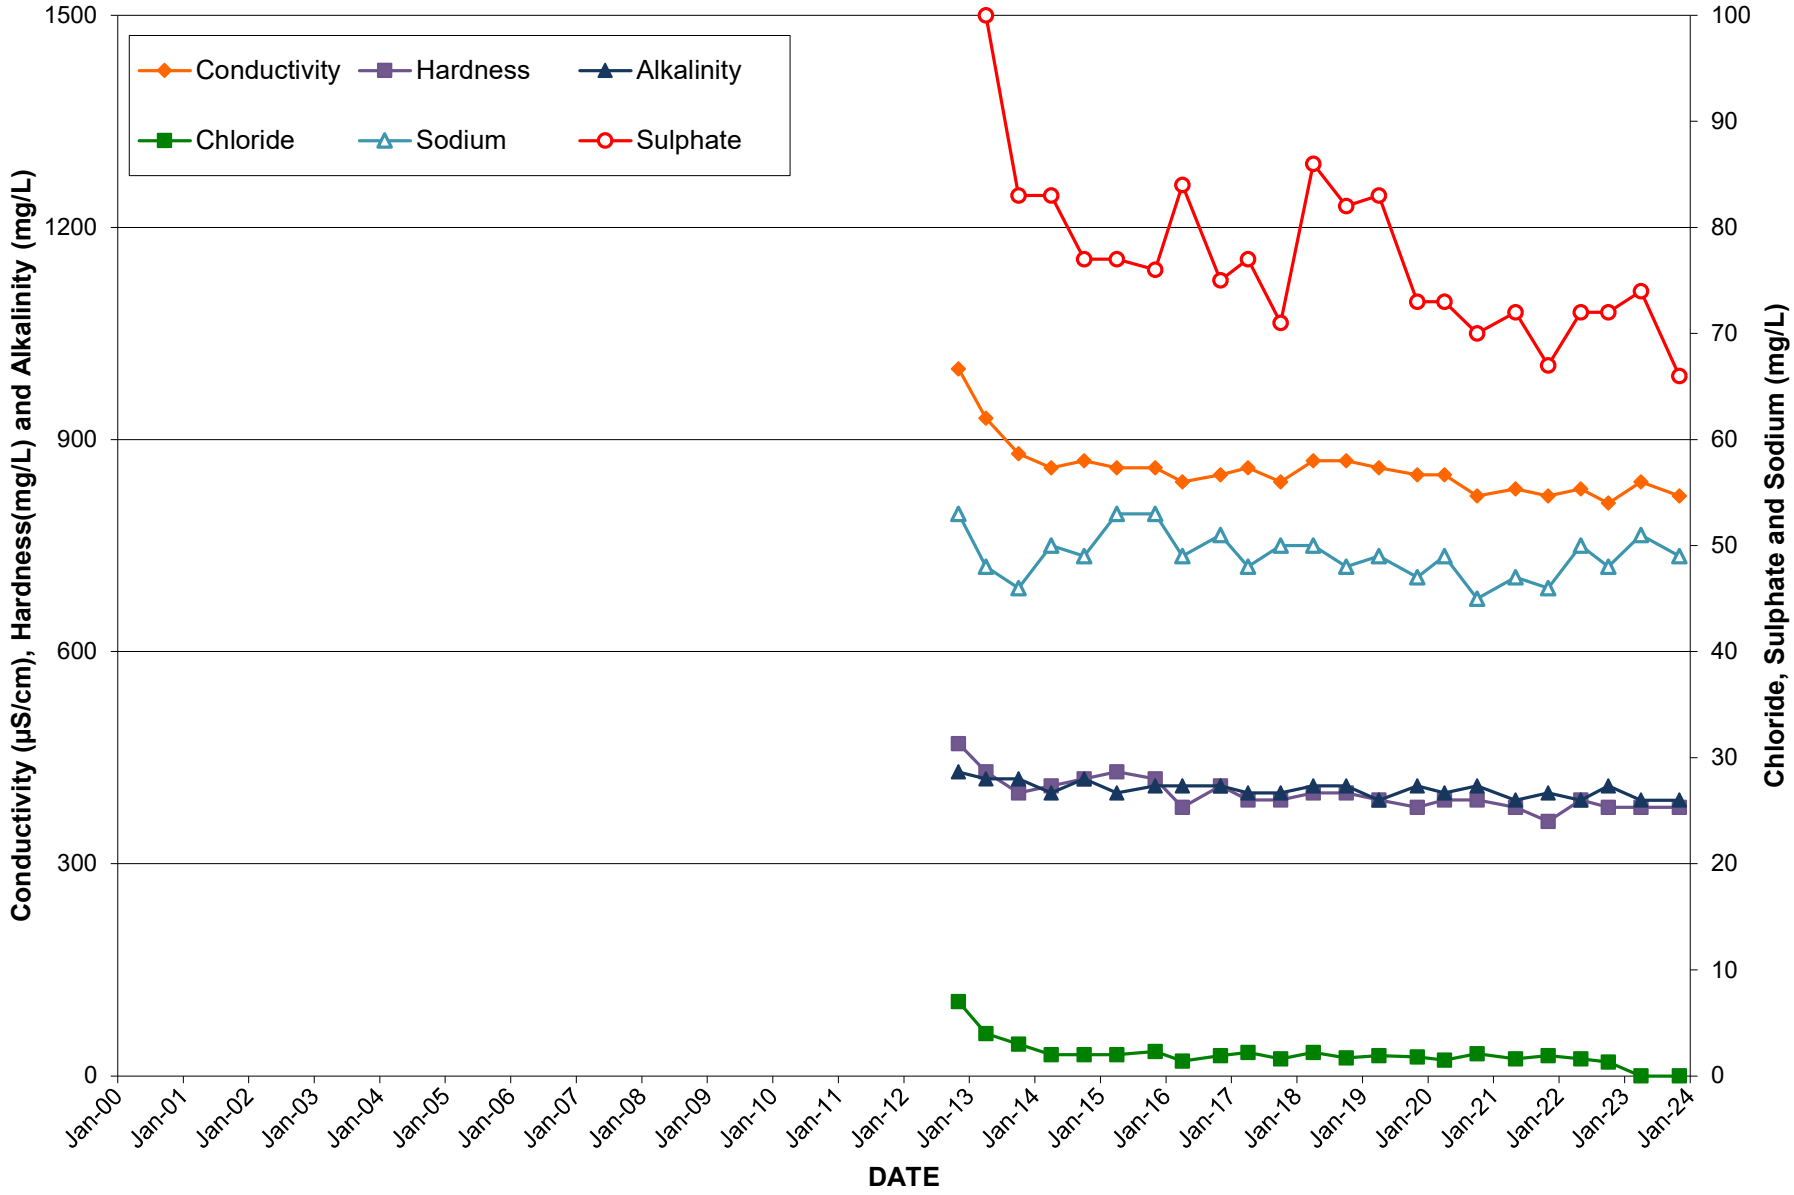
GROUNDWATER SAMPLING LOCATION: TW-24

Monitoring well TW-24, which was installed in 2012 to monitor groundwater quality down-gradient of the northerly limit of landfilling and within 40 meters of the old fill area, suggests that, at this time, landfill-leachate derived impacts continue to be limited to non-existent in this area of the Site. It is however noted that once active landfilling is re-located to the northern limit of the approved fill area, leachate influence may become more apparent at this monitoring location.
