Annual Progress Report (2023) - Arran Landfill

Municipality of Arran-Elderslie
ECA No. 0441-4J2HV8 and No. 7585-8QKL5Q

GMBP File: M-1174

March 2024

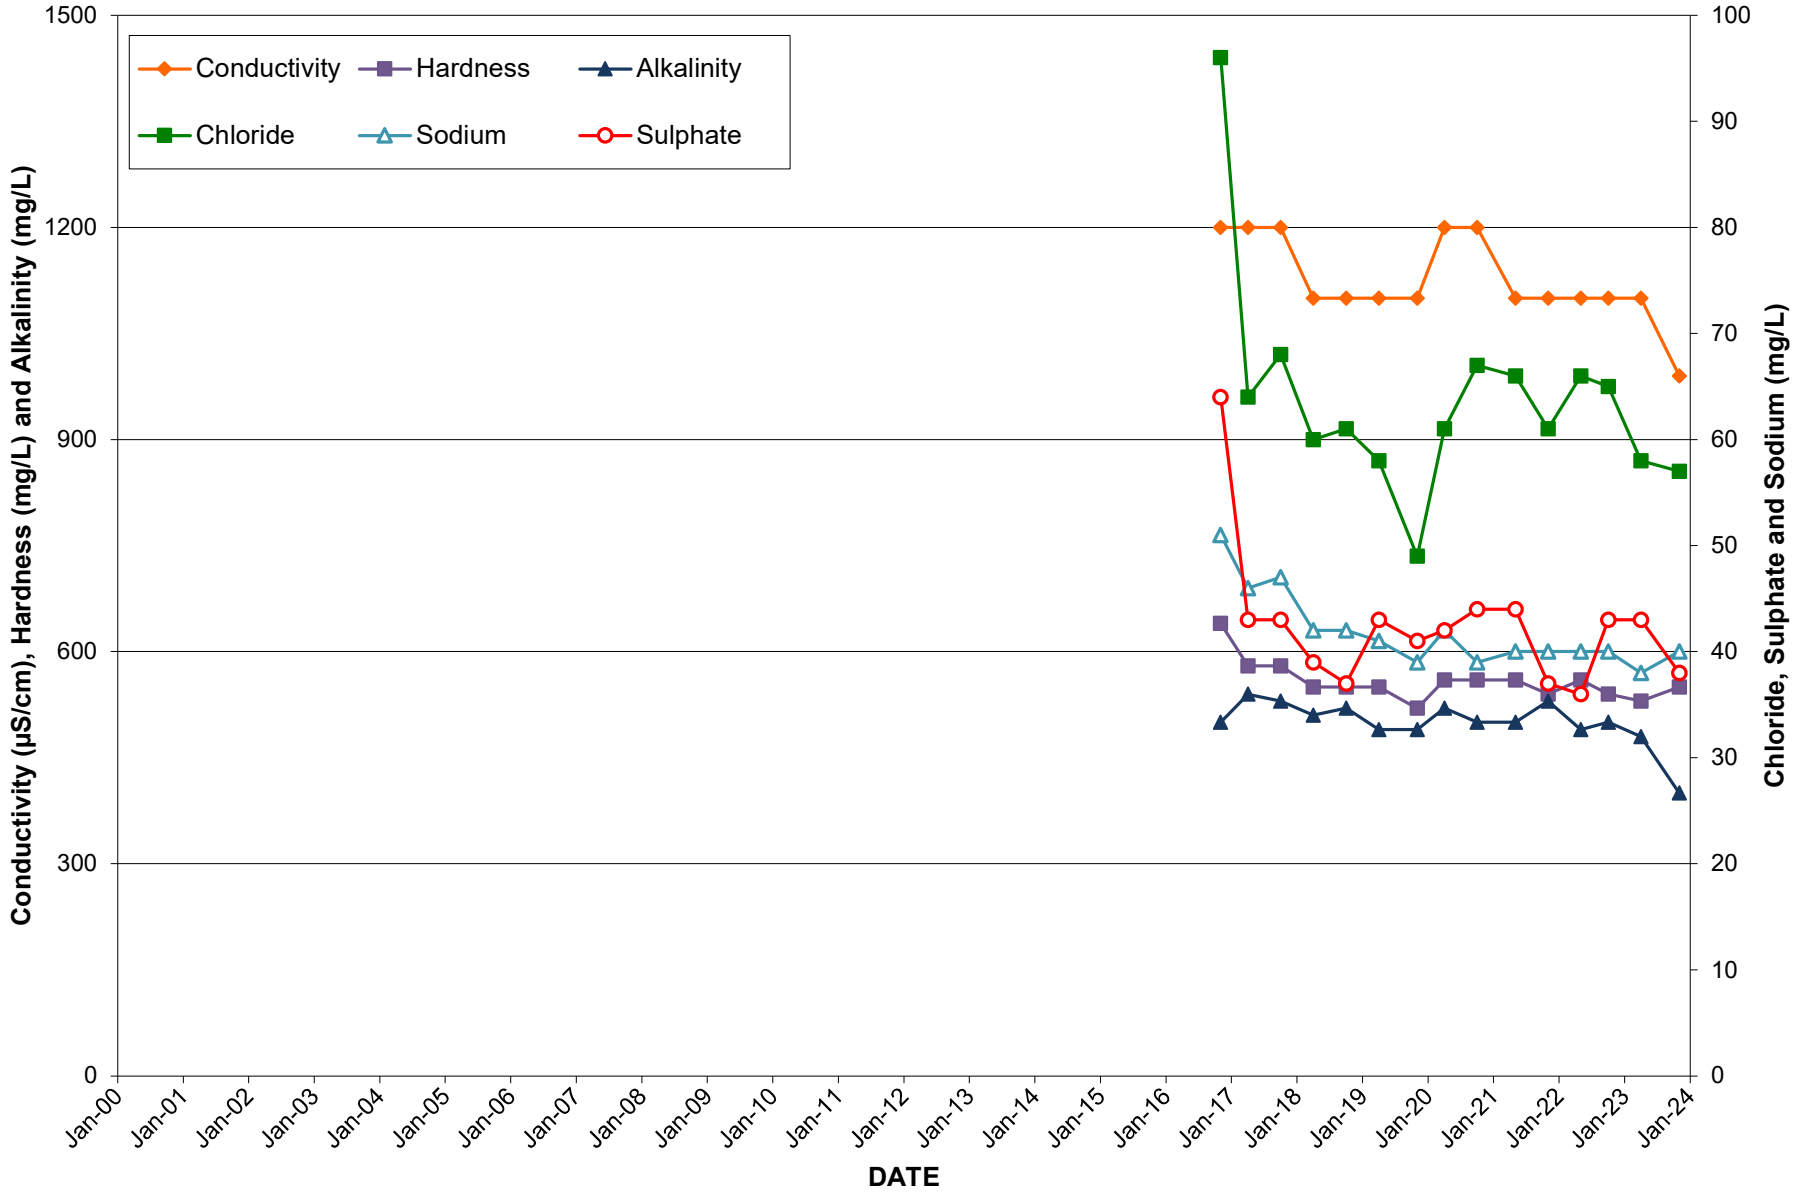
GROUNDWATER SAMPLING LOCATION: TW-27

Consistent with historical results from TW-9 and those previously reported for TW-27, in 2023 minor RUC exceedances were noted for TDS, alkalinity and hardness at well TW-27 (Table 7). While these exceedances are likely indicative of leachate-impacted groundwater at this location, they are also attributed, at least in part, to impacts from road salting along the Municipal Road (refer to Appendix E - graph).
